# Fouling Release Coatings Combat Fouling

**Power Generation &  
Water**

**Treatment Facilities**

**4 Case Histories**

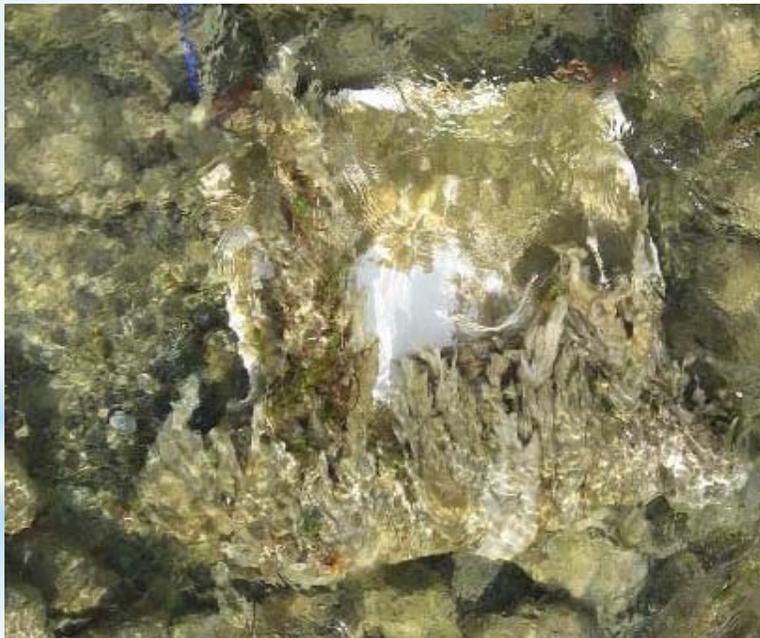
Panel without FR Coating

1. Initial testing would be on coated test panels placed in the infested rivers by the power company.

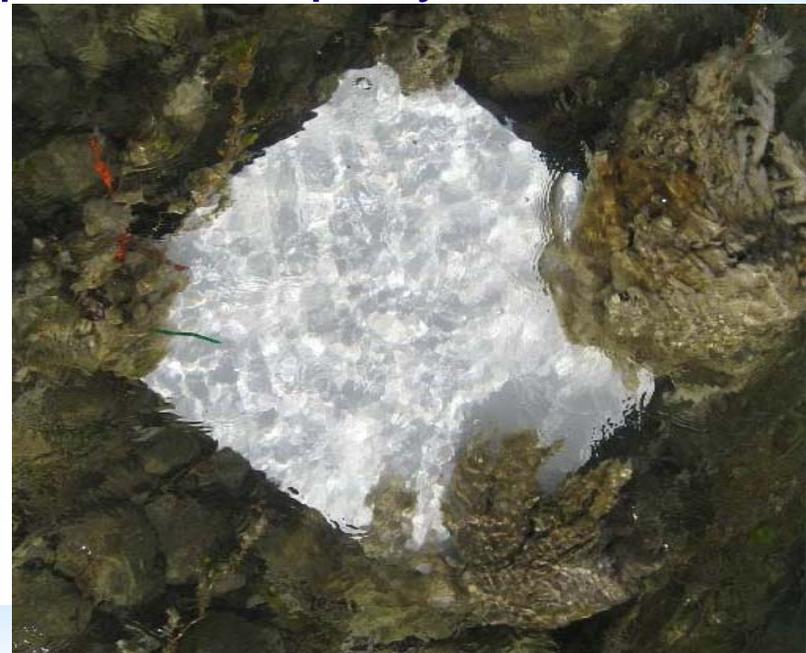
Panel with FR coating

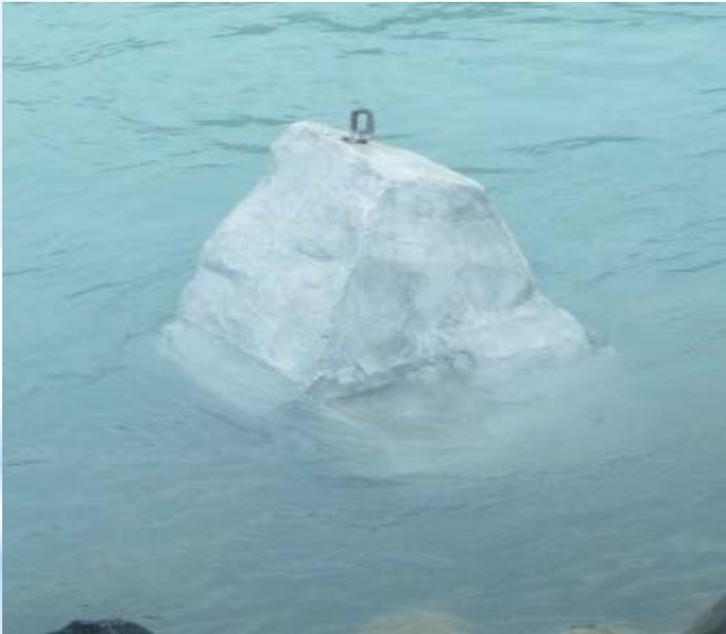
At time of immersion

2. Successful results, a second phase of testing application of the coating system by a New Zealand industrial painting contractor ***to naturally occurring indigenous river boulders.***

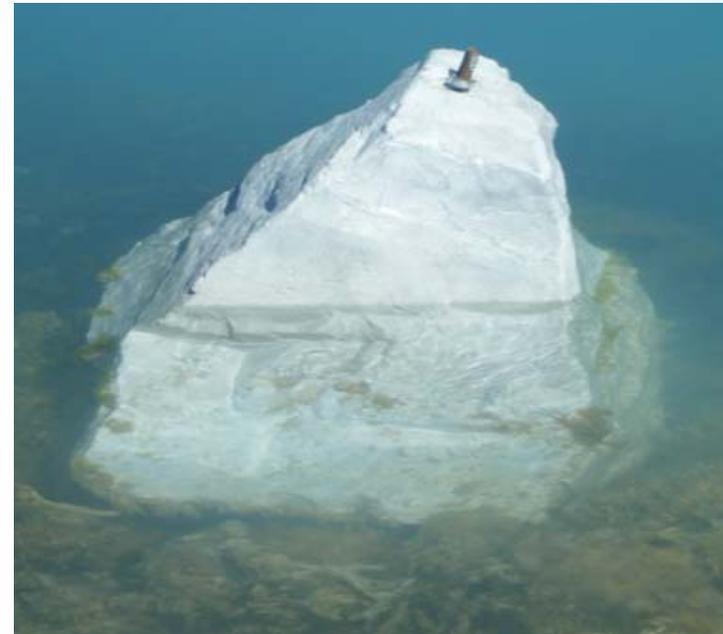
Minimal fouling after 10 months

The ***owner considered the results successful.*** A concluding summarization by the owner stated:

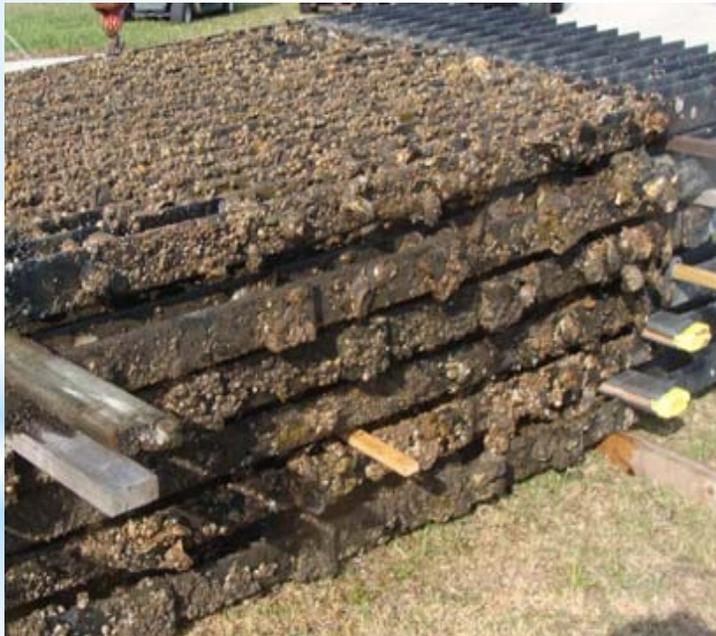
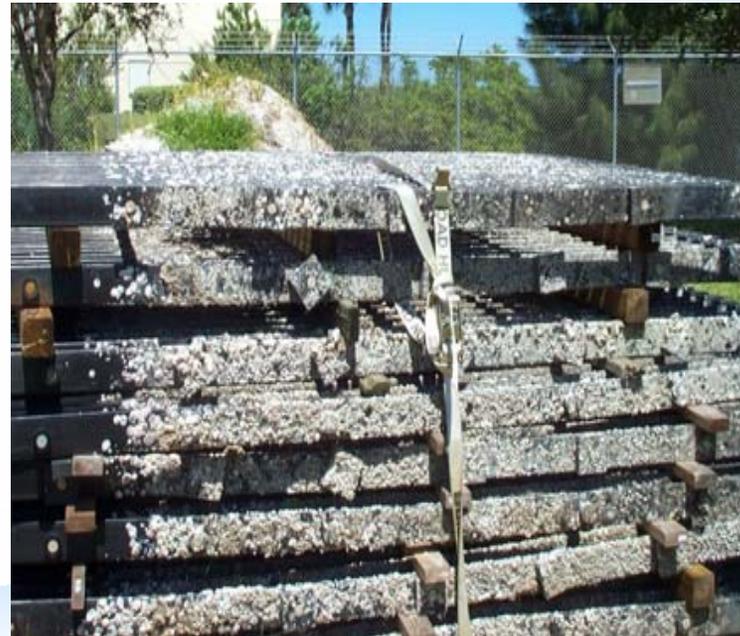
Fouling on intake trash gates **prior to installation** of FR coating system

Solution to **barnacle attachment on the power plant's intake grates** constructed of high density polyethylene plastic (HDPE). ***Not only was water flow restriction from the fouling & increased maintenance cost for cleaning during outages.***

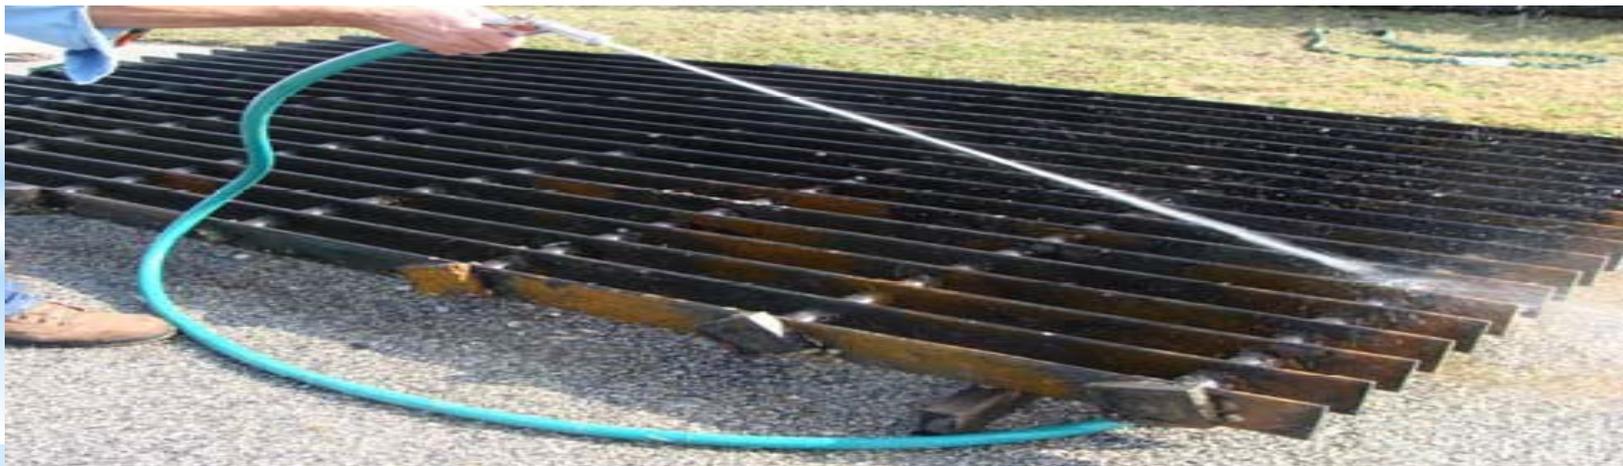
Cleaning of coated trash grate with a garden hose

- 18 months of performance removed, inspected and easily cleaned. Inspection revealed a few barnacles had attempted to attach and a yellowish slime had settled on the surfaces.
- Cleaning of the grates was successfully accomplished with little effort using water at normal garden hose pressure.

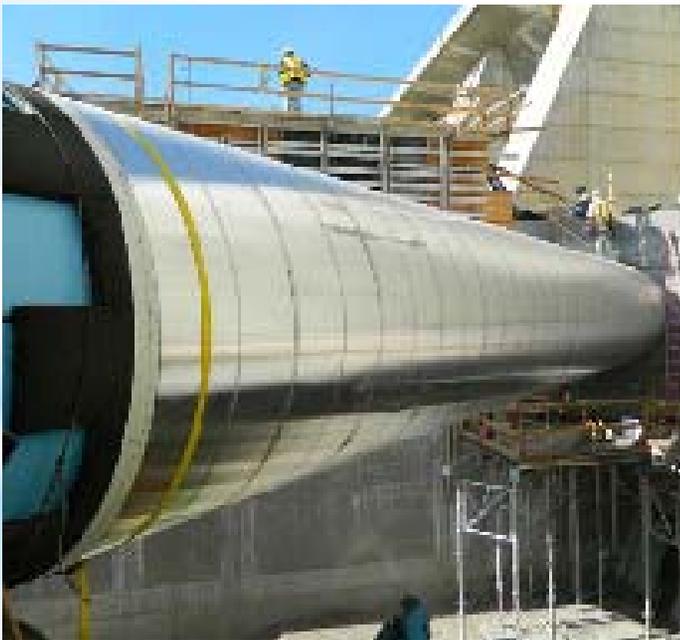
Delivery pipe exiting dam face

Approximately 110 feet X 96 inch diameter steel pipe a professional industrial coatings applicator installed the fouling release coating system.

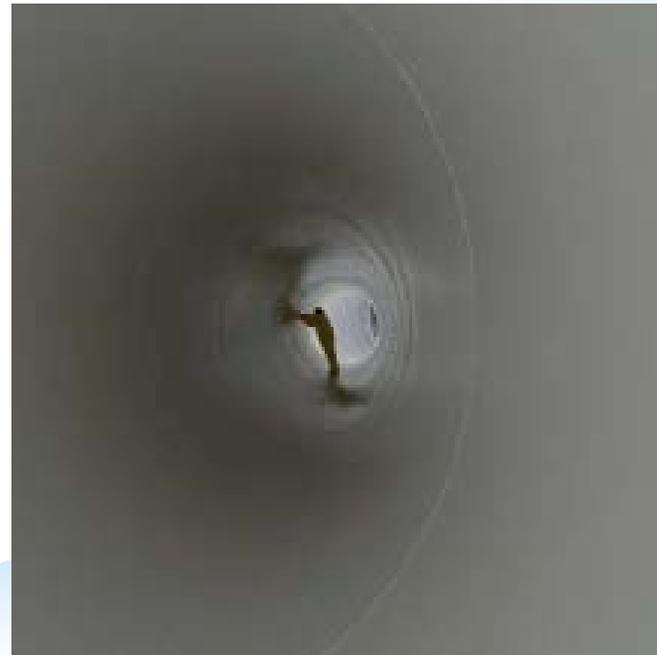
Inspection of finish coated pipe interior

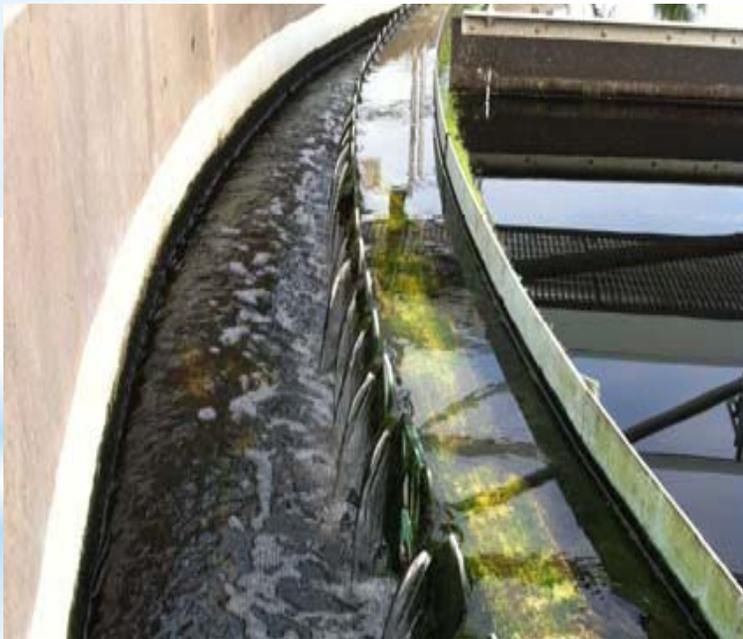
Algae conditions prior to coatings

*With continuous washing to remove algae from the concrete surfaces of clarifier weirs, the concrete eroded becoming rougher and rougher. The result was very rough concrete from which it was extremely difficult to remove the offending algae.*

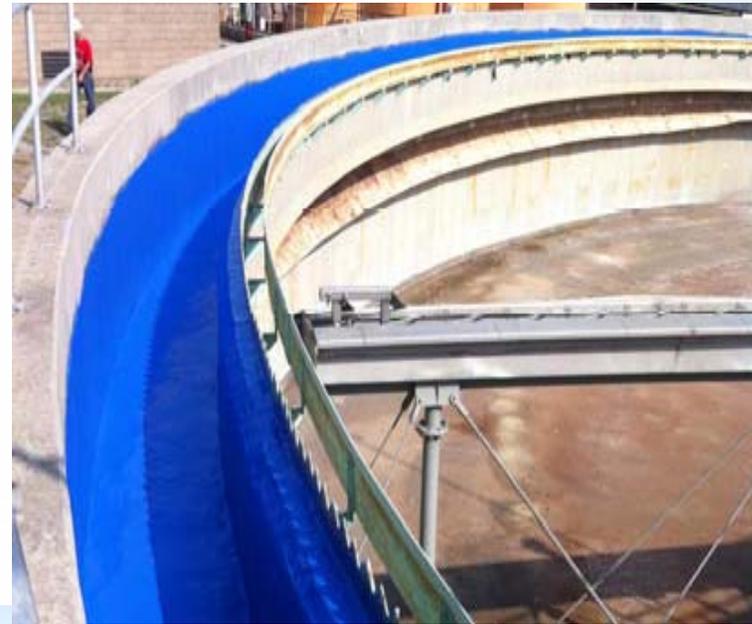
Completed fouling release coating system

Eroded & aggregate exposed concrete was repaired with a cement patching material. The FR system was applied (while not normally recommended, the coating system was applied with appropriate precautions at ambient air temperatures above 100 degrees F).

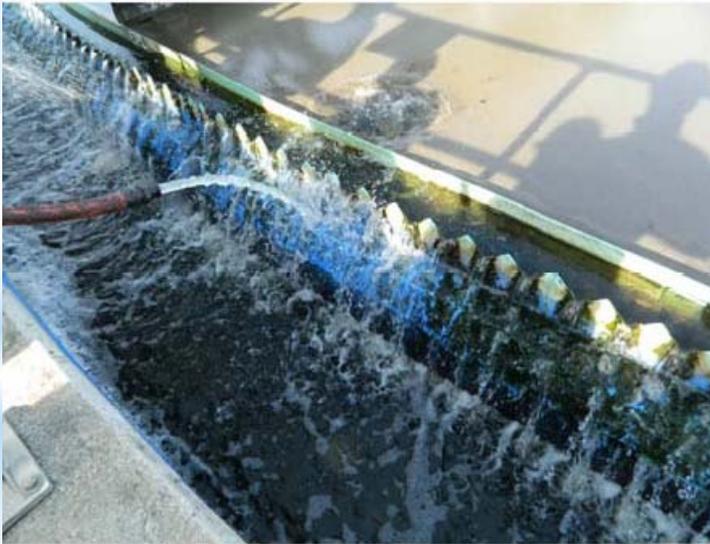
Low water pressure garden hose cleaning

As expected, algae continued to grow in the weirs. However, cleaning was accomplished in short order with lower pressure water through a garden hose without harm to the coating system or underlying concrete substrate.

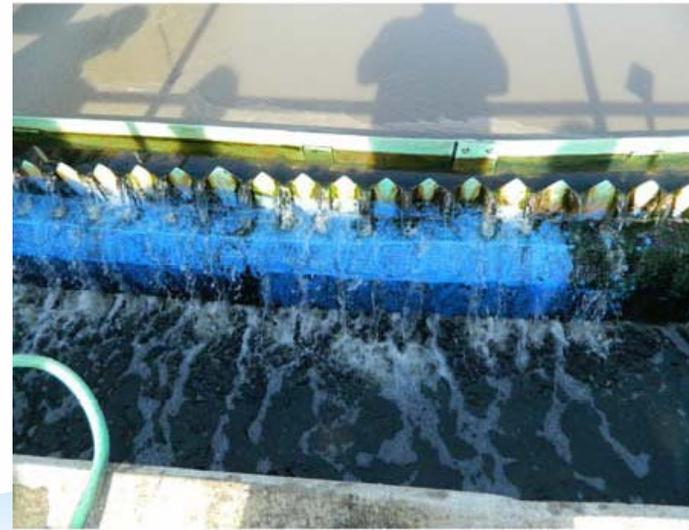
Results after one minute of cleaning
