RECLAMATION

Quest for Durable Foul-Release Coatings

Funding: Reclamation Science & Technology Program

U.S. Department of the Interior
Bureau of Reclamation

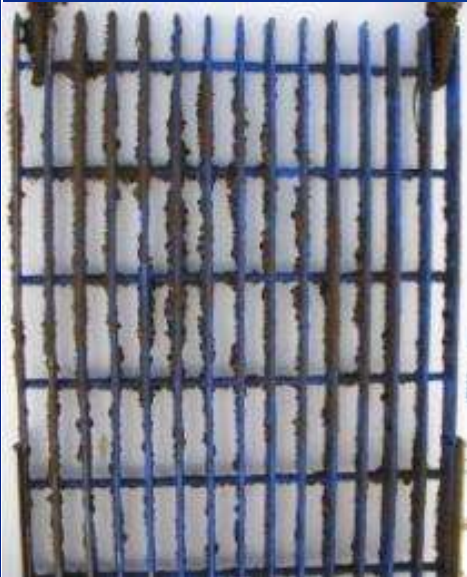
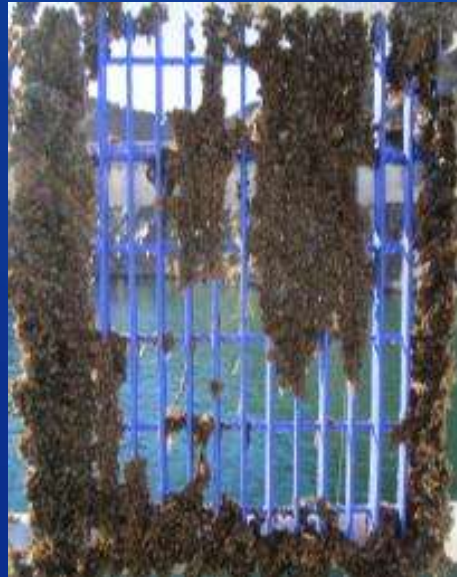
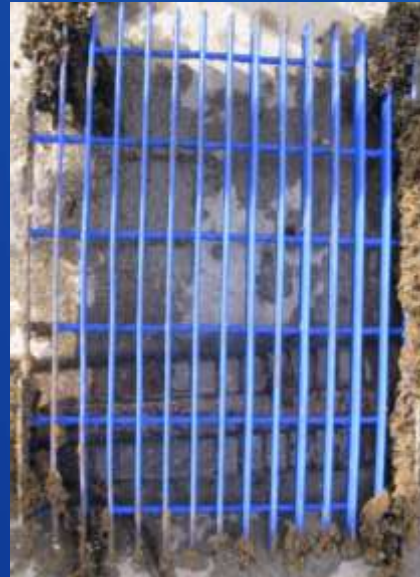
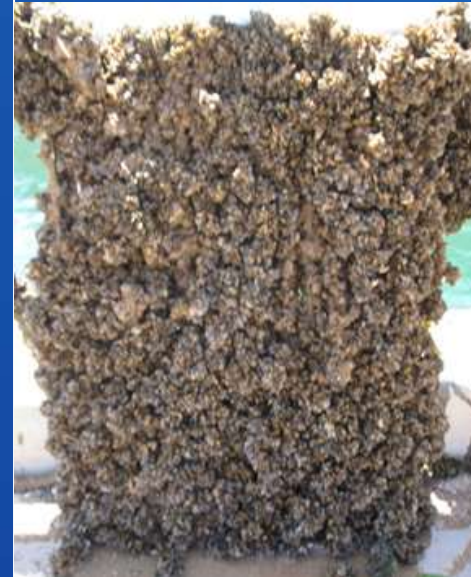
- Silicone foul-release (FR) coatings prevent mussel attachment for many years

Control

2 years

5 years

7 years

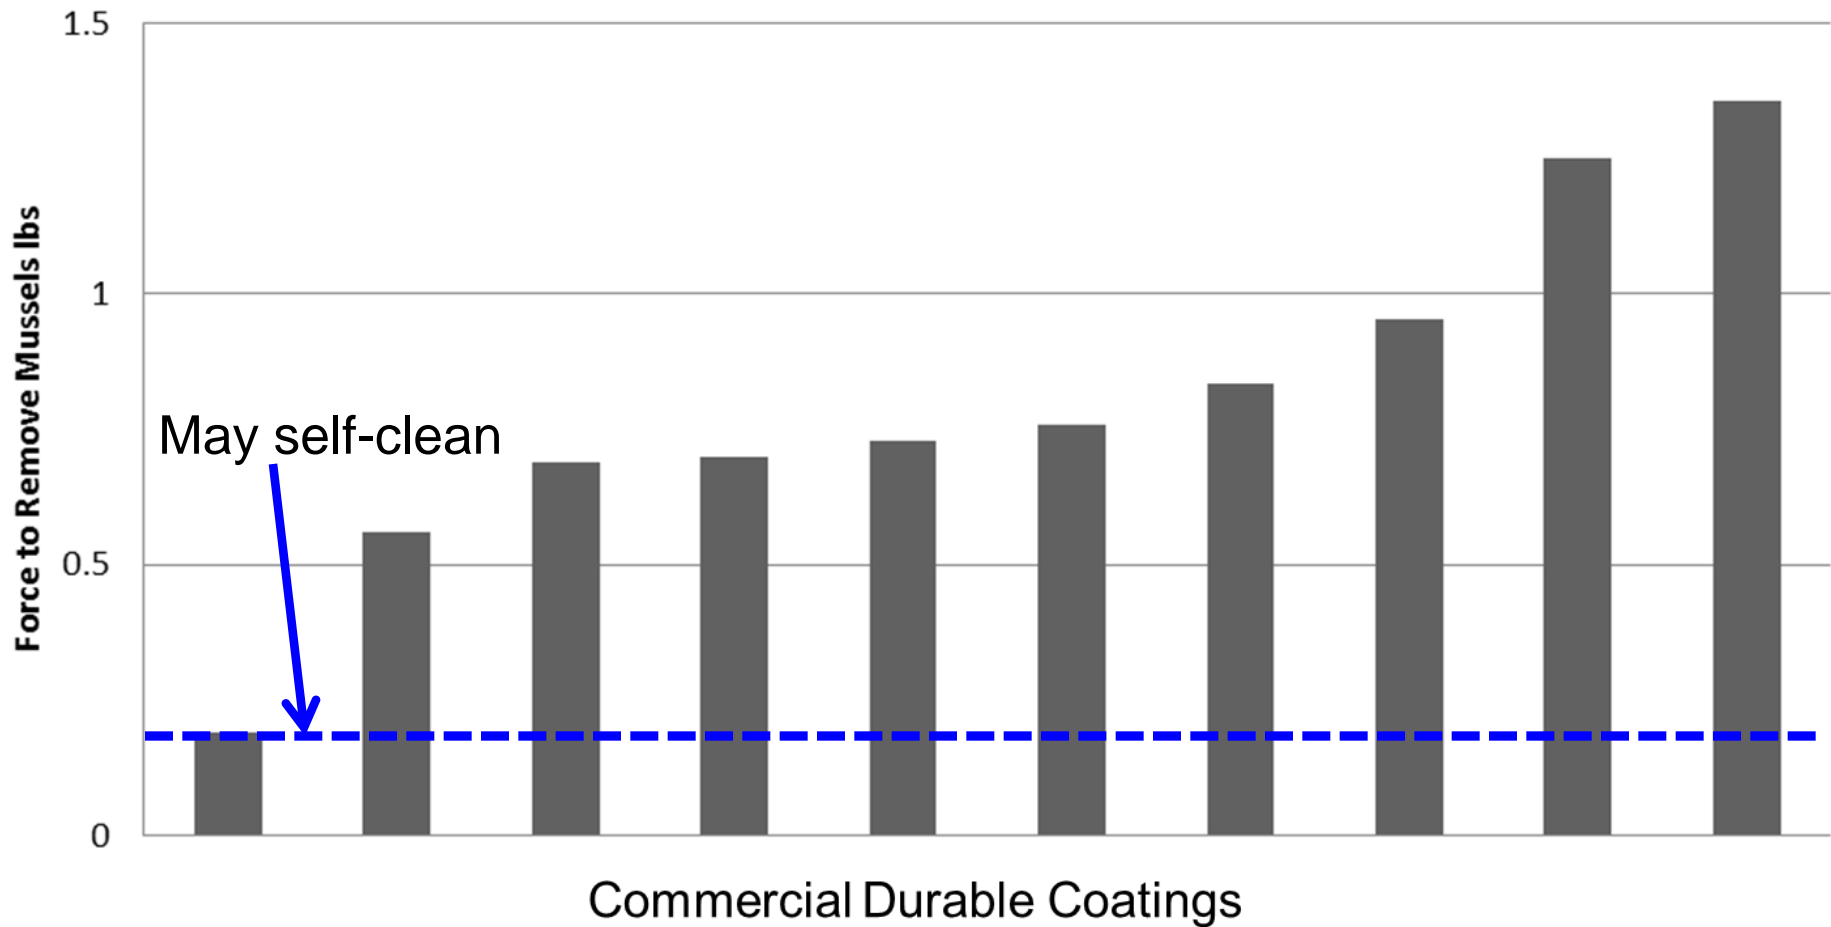
Durable Materials Results

- Some success for coatings

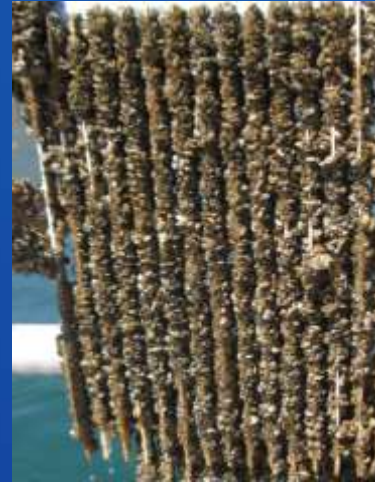
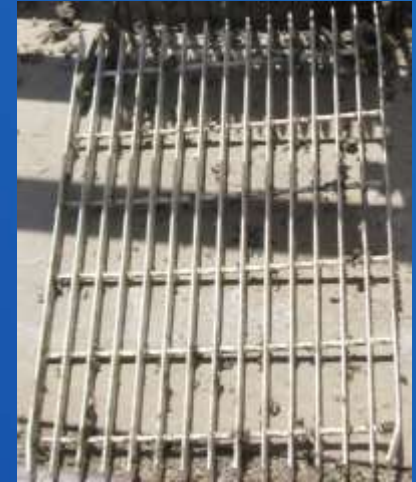
- Anti-ice coatings as low as 0.0-0.4 lbs and easily cleaned
- Two of six gaskets prevent attachment

Before

After (cleaned)

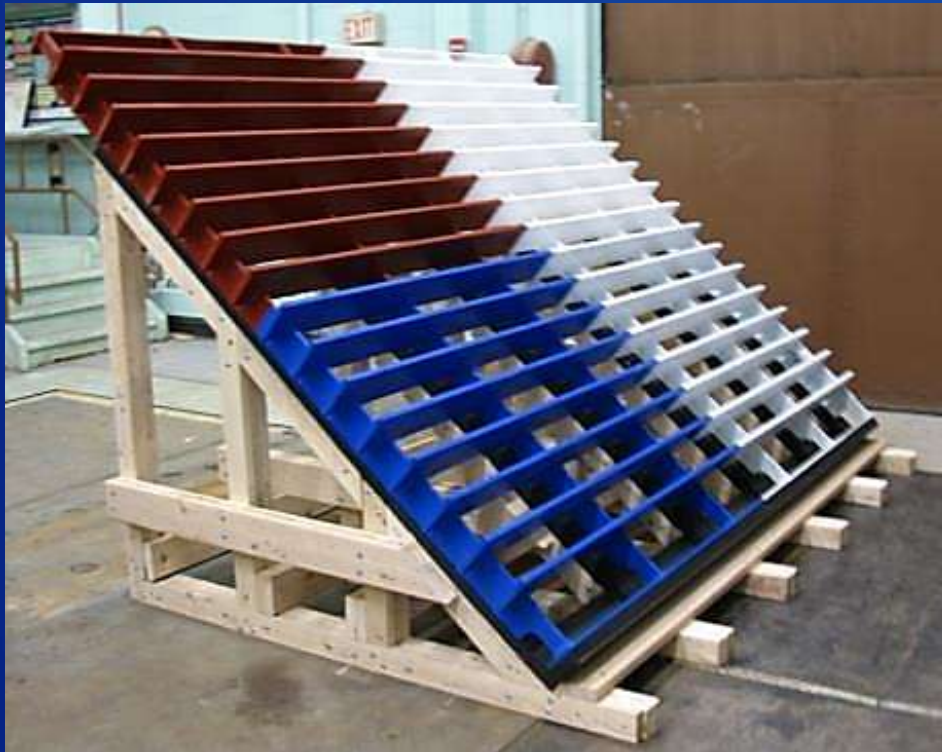
- Fish screens (brush cleaner)
- Trashrack (trash rake cleaning system)

Generic Coating Type	Location
Silicone FR	Top left
Fluorinated silicone FR	Top right
Silicone FR	Bottom right
Epoxy silicone hybrid	Bottom left

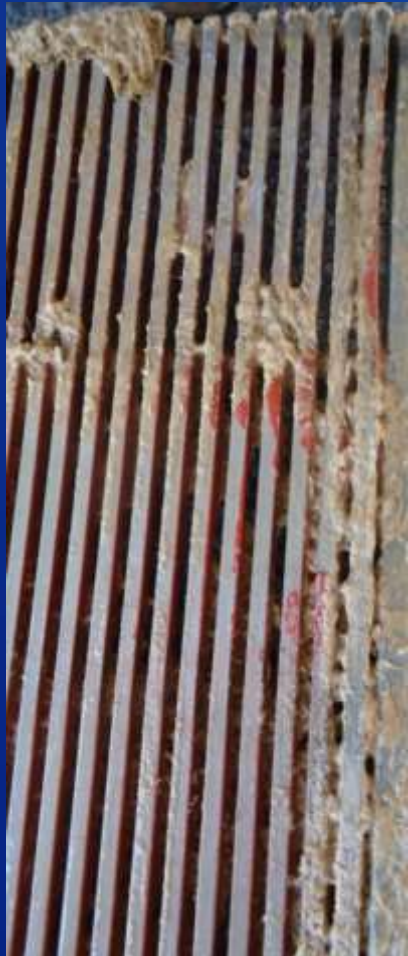
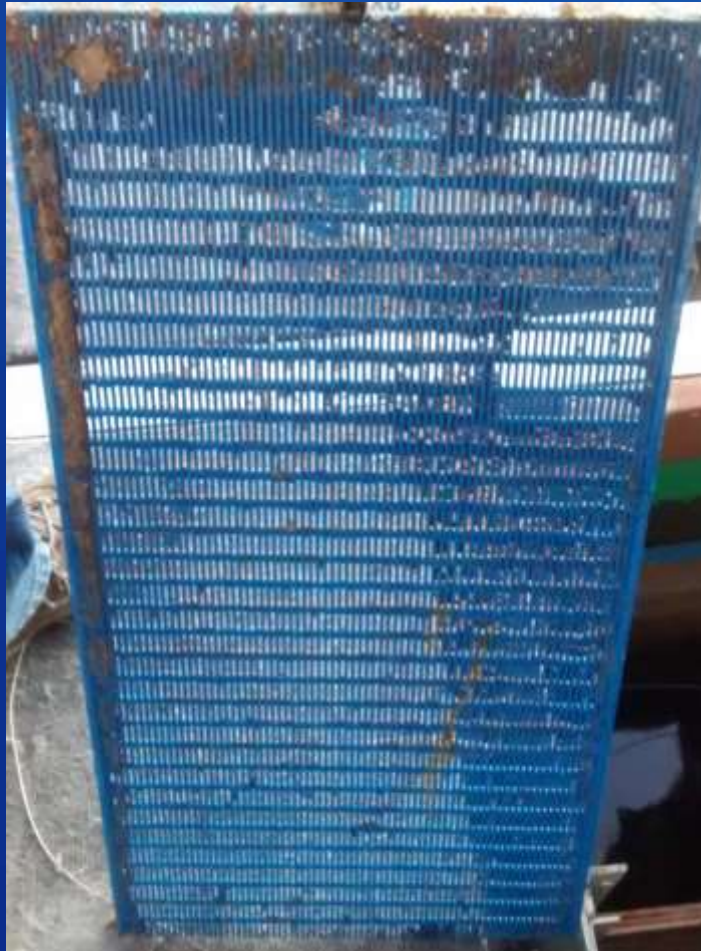
Fish Screen Results

Abrasion from the nylon brushes

Soft FR coatings damaged easily

Hard FR coating undamaged

Foul release (left) and durable (right)

- Scale-up studies showed that material success is dependent on service events
 - Nylon brush damaged soft foul release coatings
 - Galvanized trash rake damaged hard foul release coating
- Continued testing of durable materials
 - Good mechanical abrasion resistance
 - High tensile and tear strength
 - Low mussel attachment forces

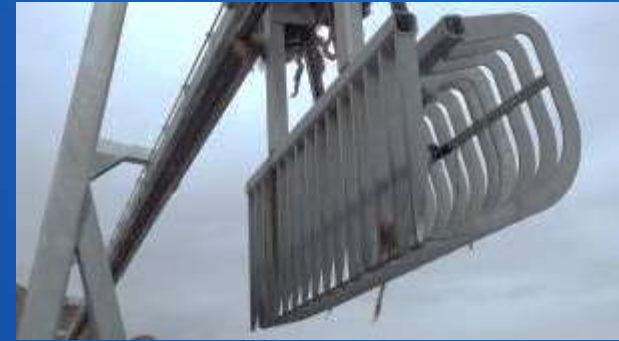
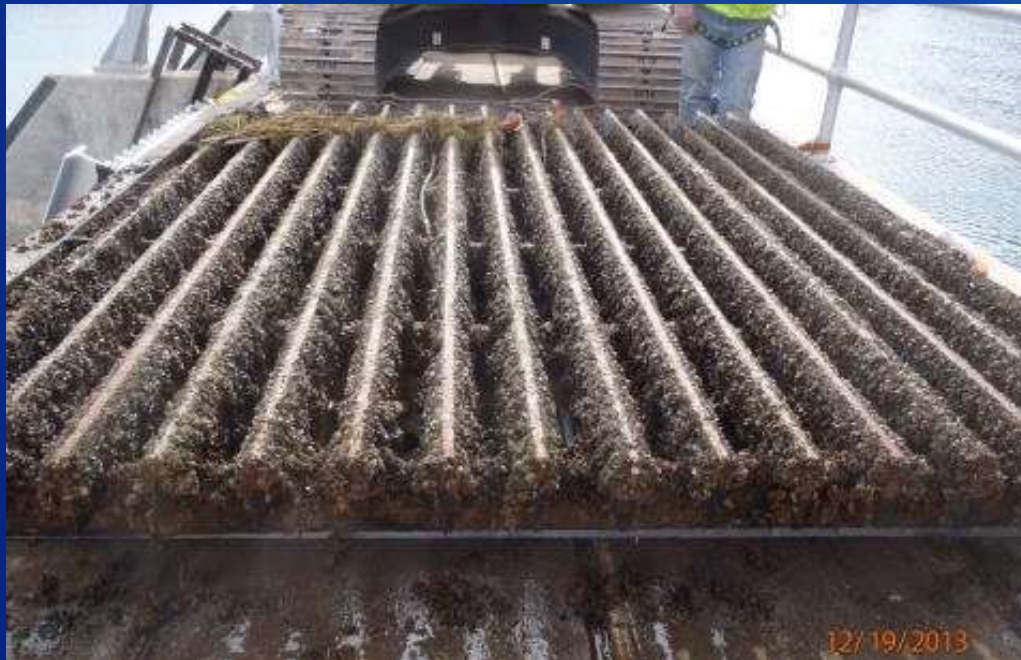
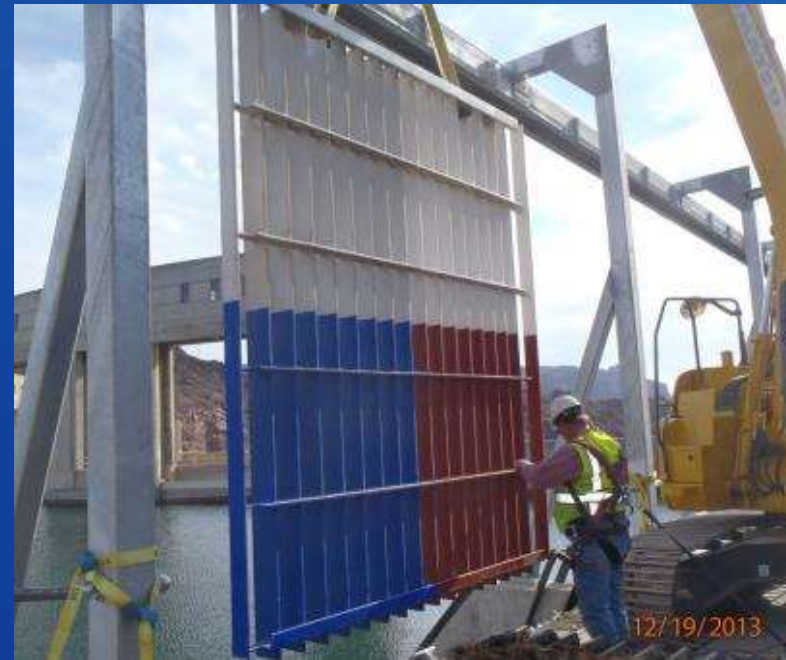
Trashrack Installation

Rake Head

- Trash rake cleaning system
- Out with the old...

Existing trashrack (left), new (right)

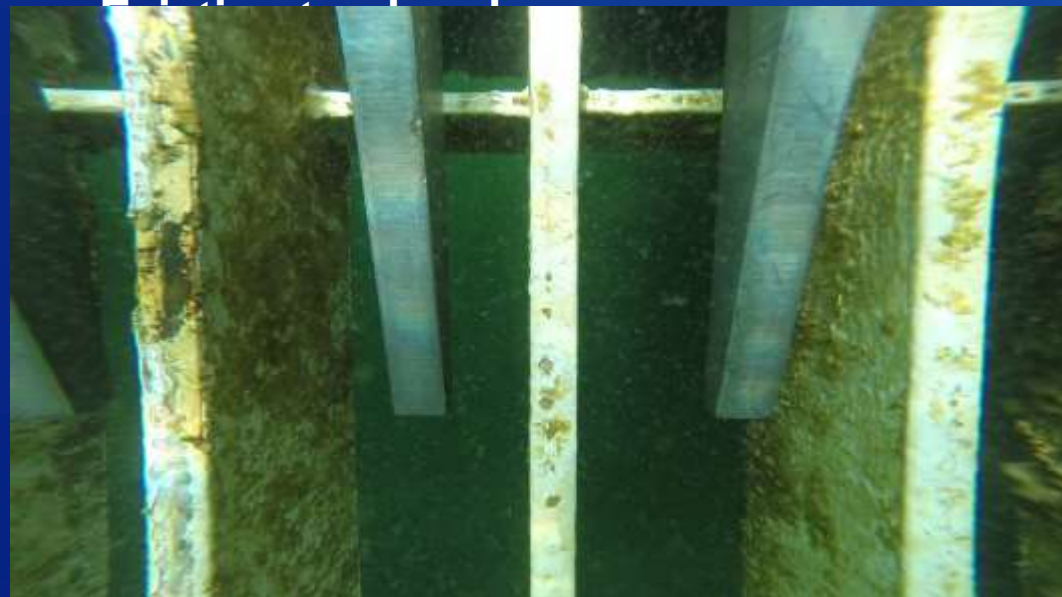
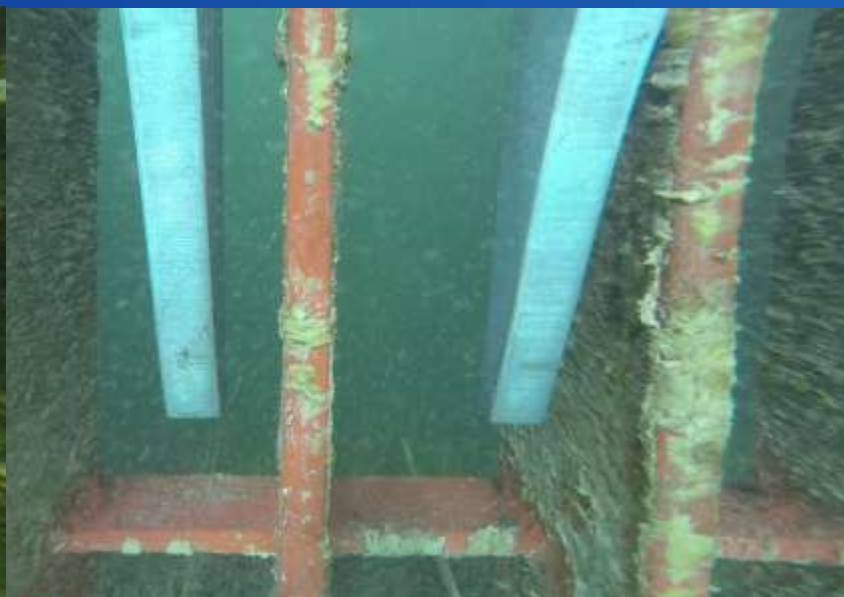
Trashrack Results

Silicone FR coatings
had minimal damage

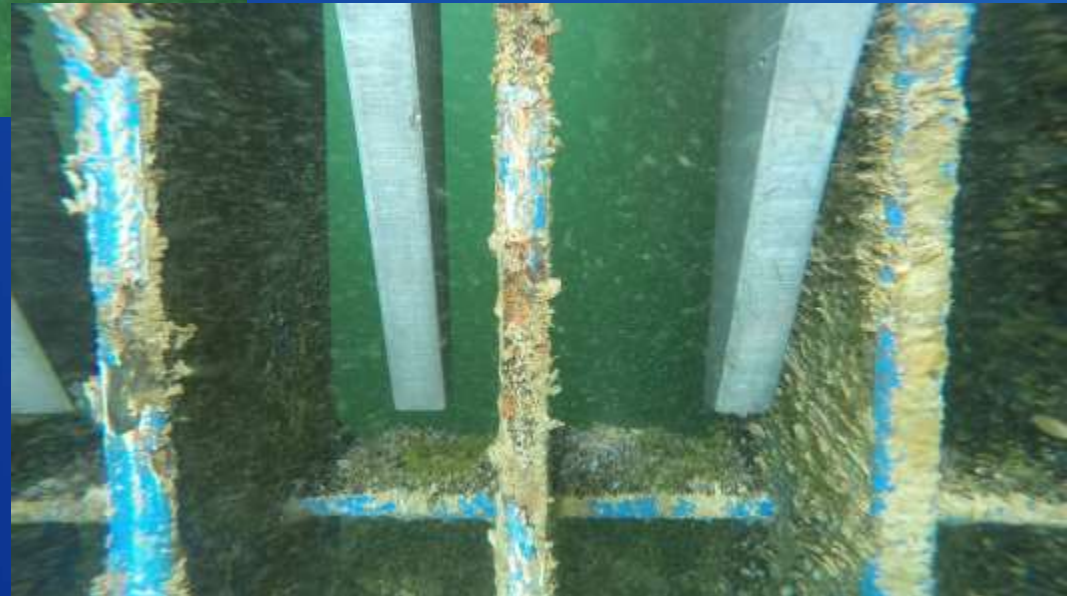
Trashrack Results

Hard FR coating
most damaged
