ICAIS – RESPONSE AND CONTROL

Taking No Prisoners Beating Back Invasive Species Bureau of Reclamation

Leonard Willett
Hoover Dam
Lower Colorado Region

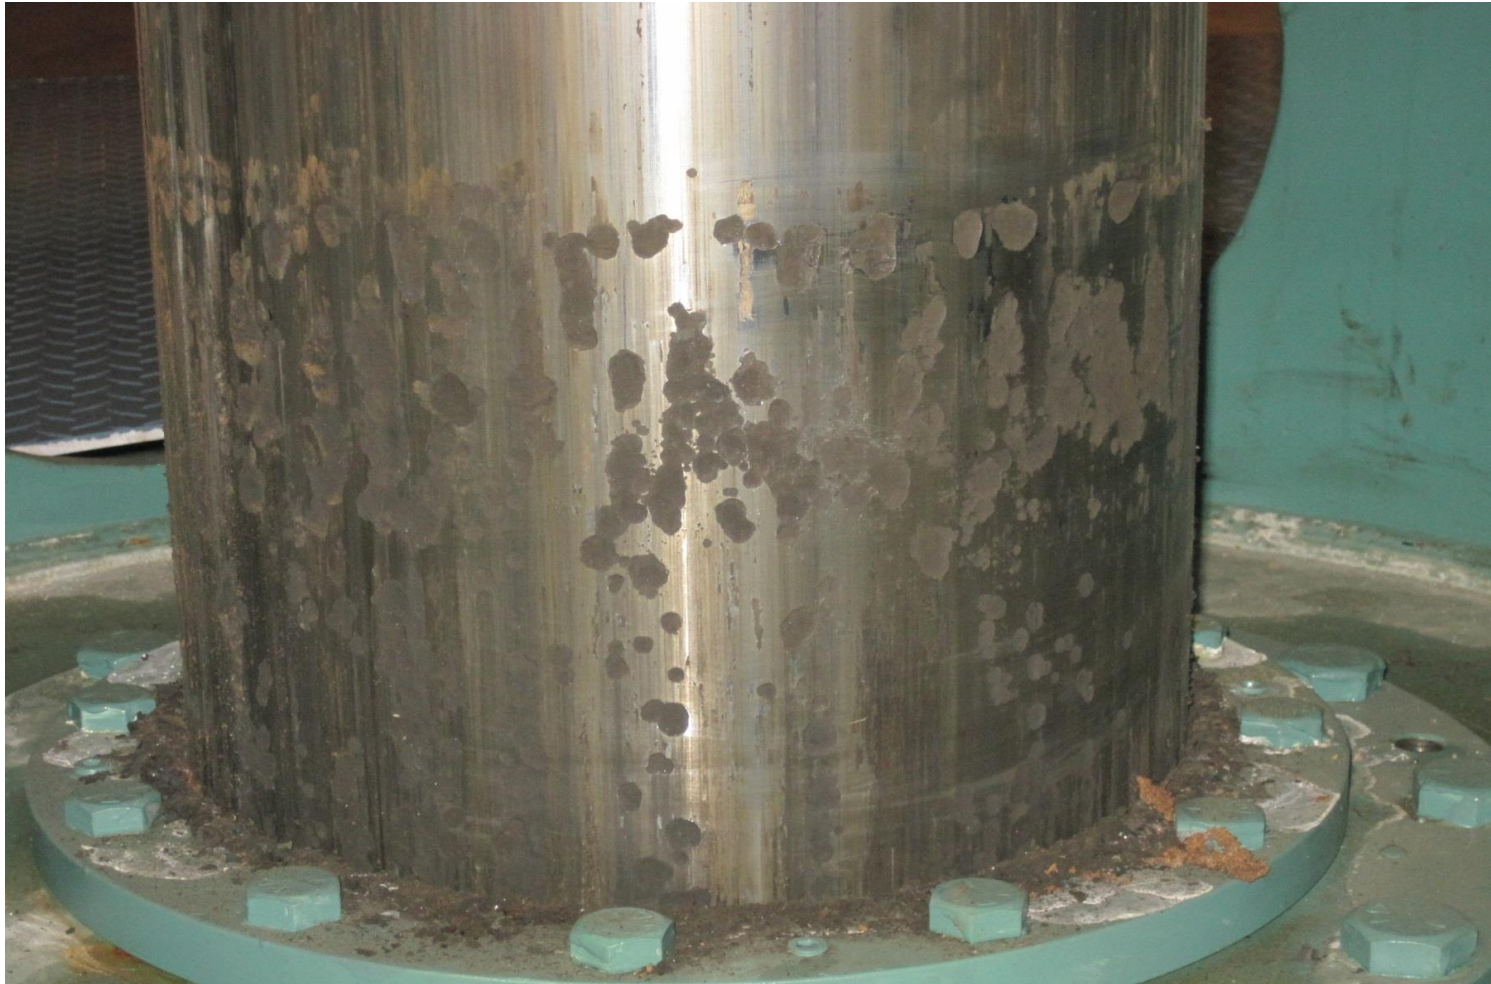
April 2013 Hoover Dam Pressure Relief Valve
Shaft Corrosion

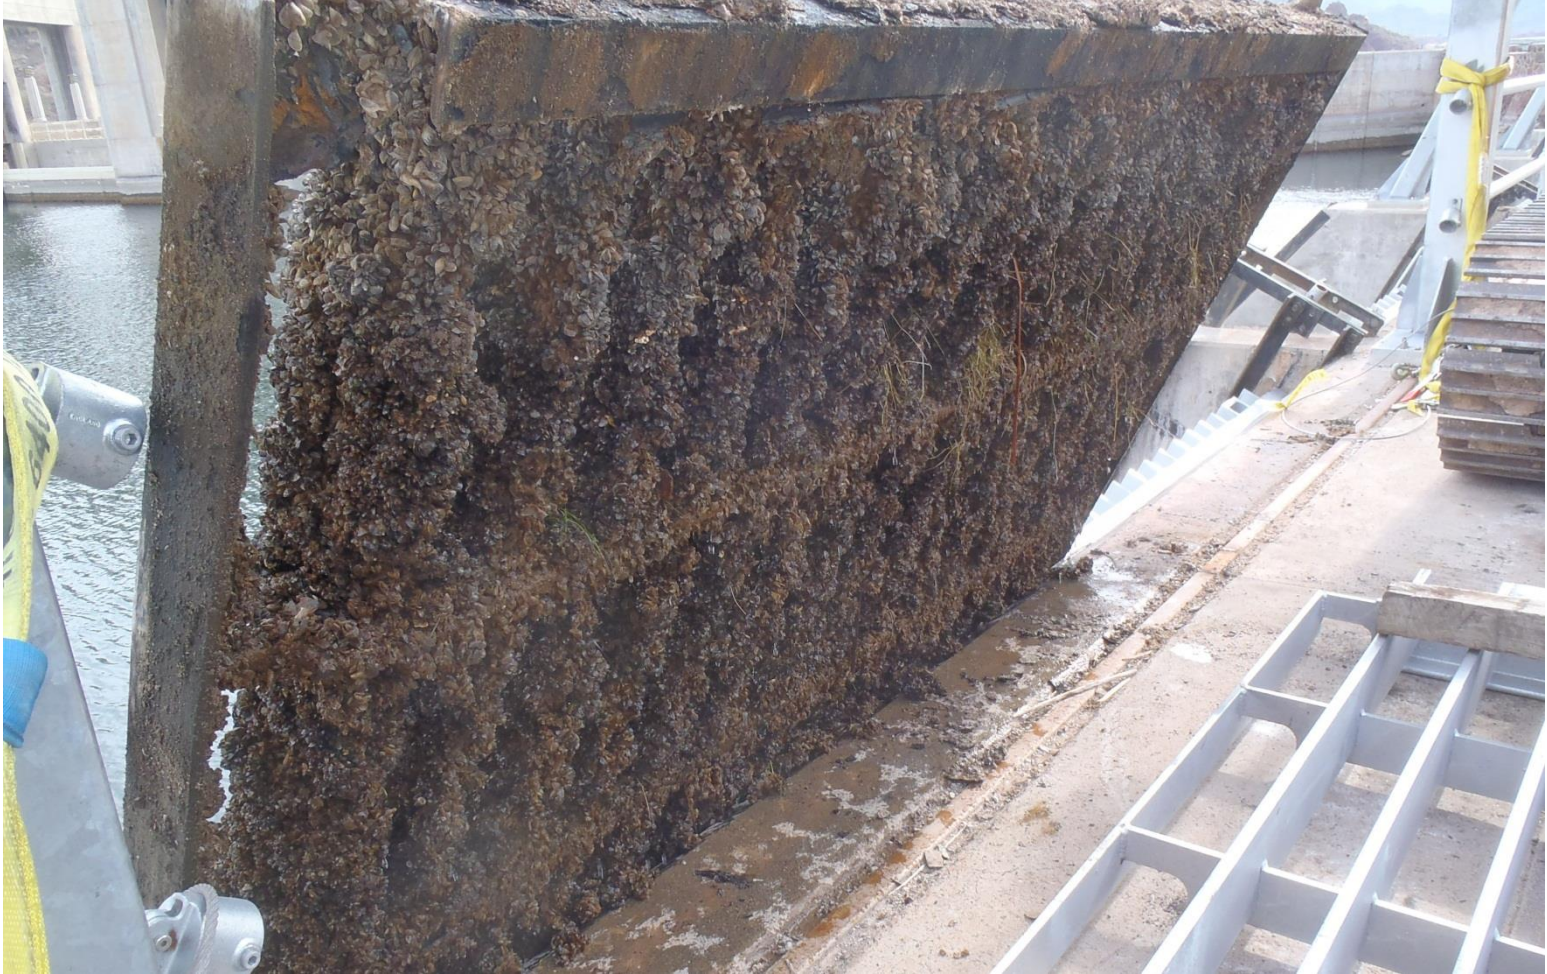
January 2013 Parker Dam Trash Rack Blockage

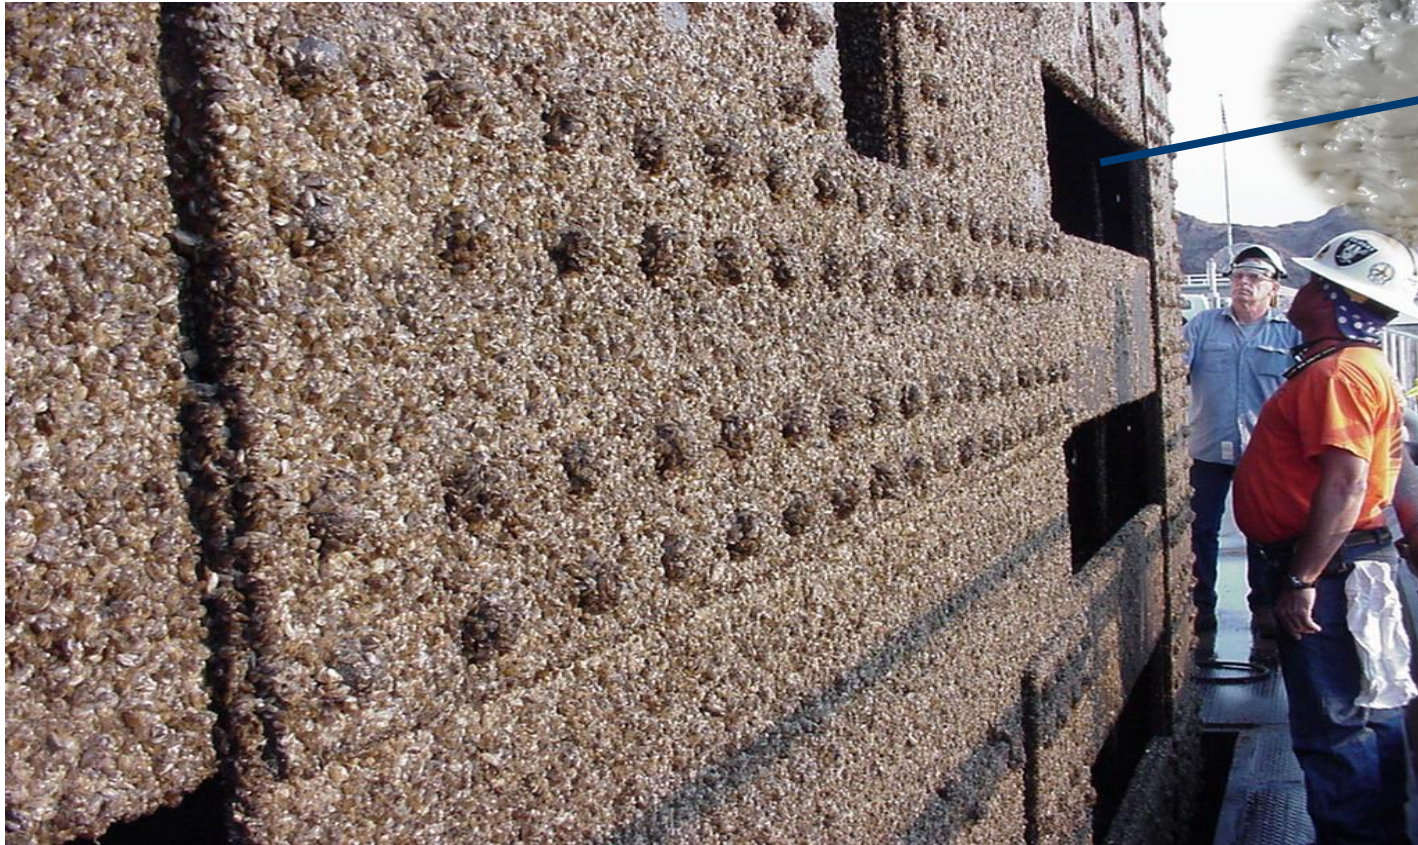
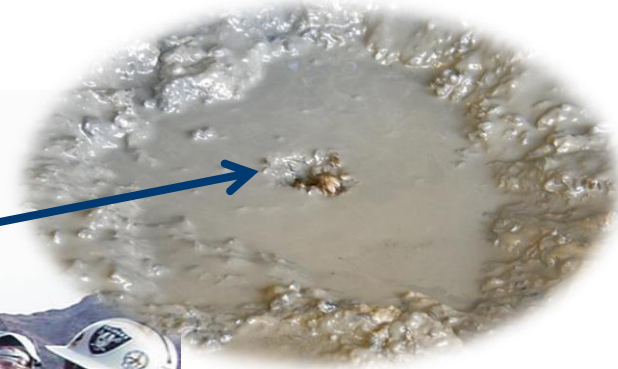
October 2007 Davis Dam Fixed Wheel Gate Blockage

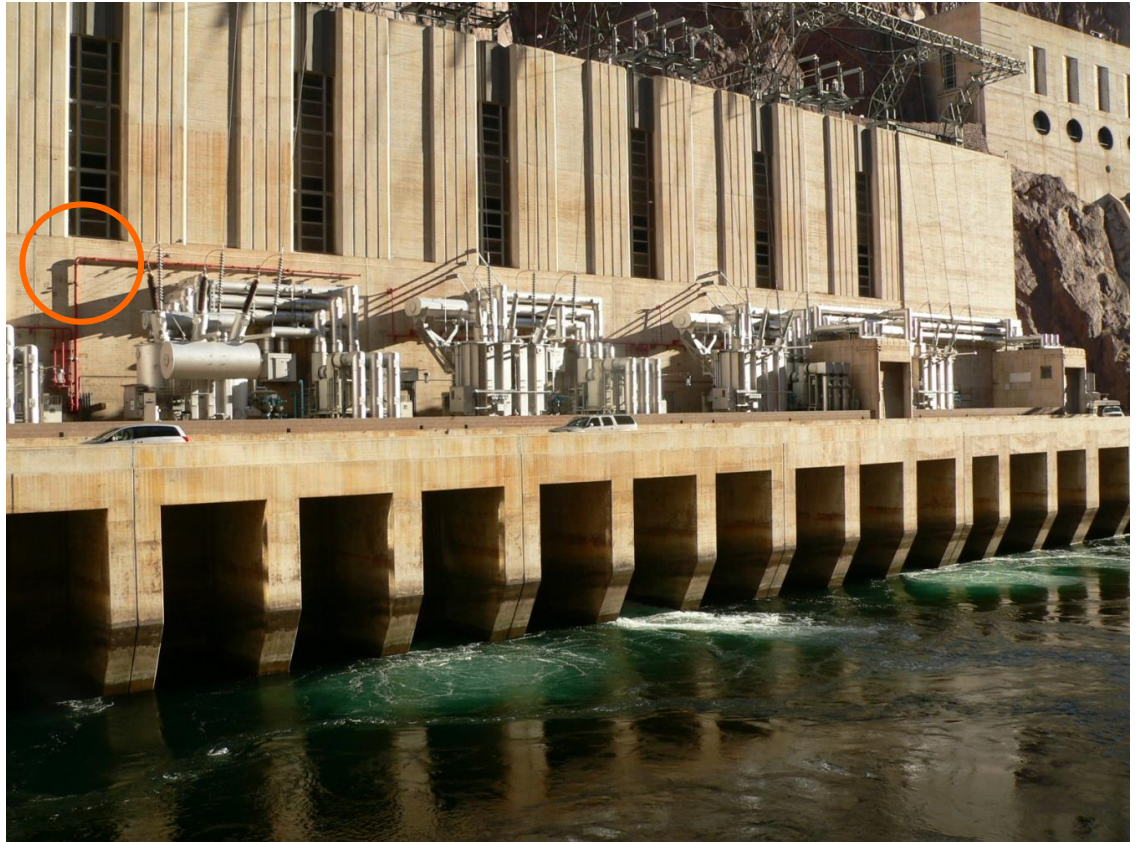
Transformer
Cooling
Water

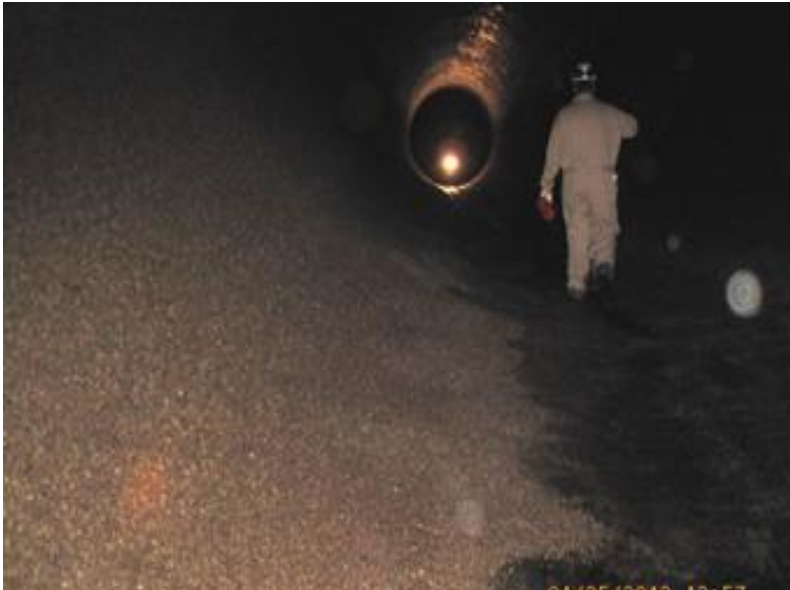
Penstock Interior Surfaces Inspection

Mussel Shell Debris in Penstock
serving Multiple Laterals

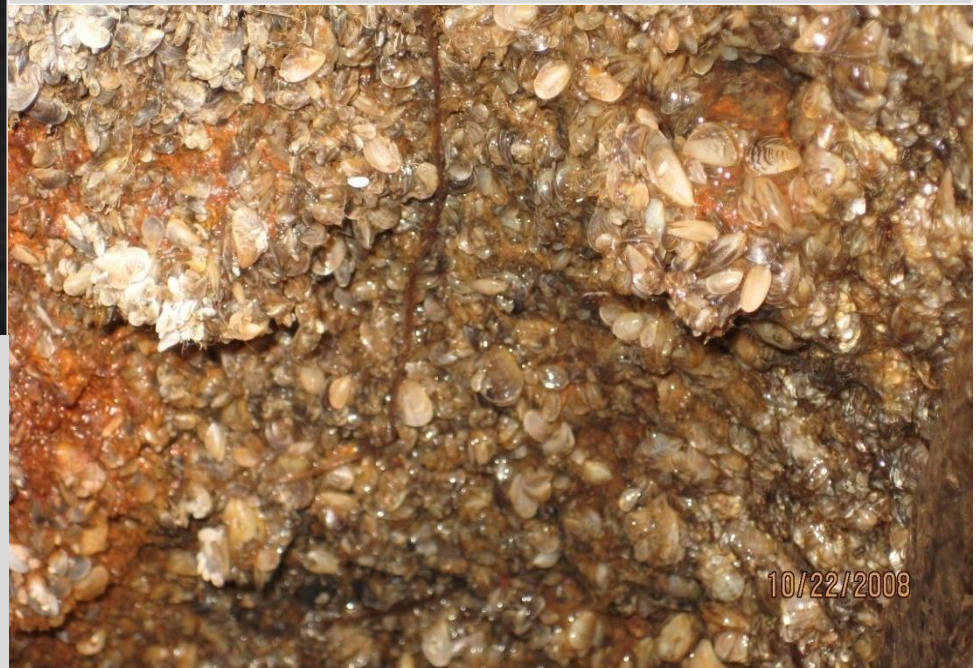
10/22/2008

Penstock Drain – Heavy Settling

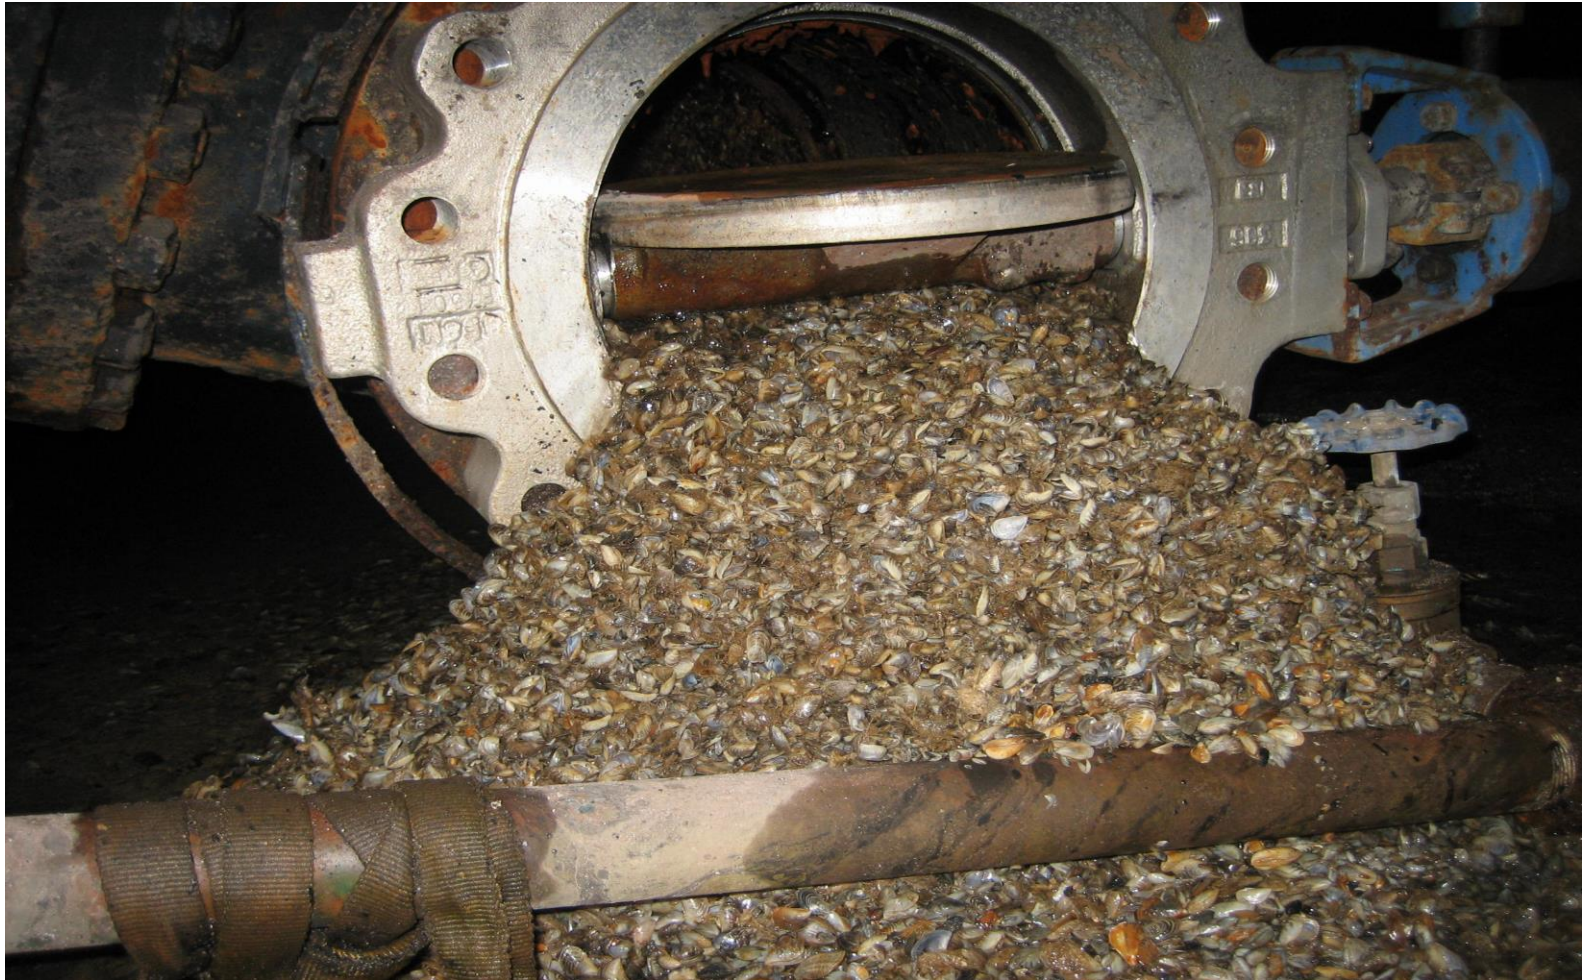
October 2010 Penstock Belly Drain

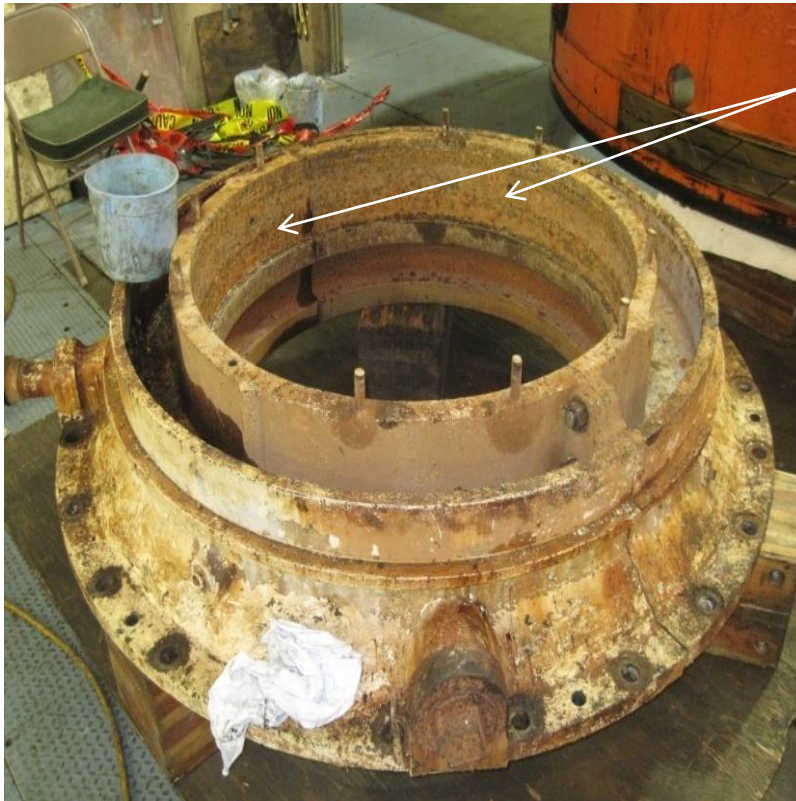
Hoover Dam Generator Packing Area Problematic Mussel Fouling

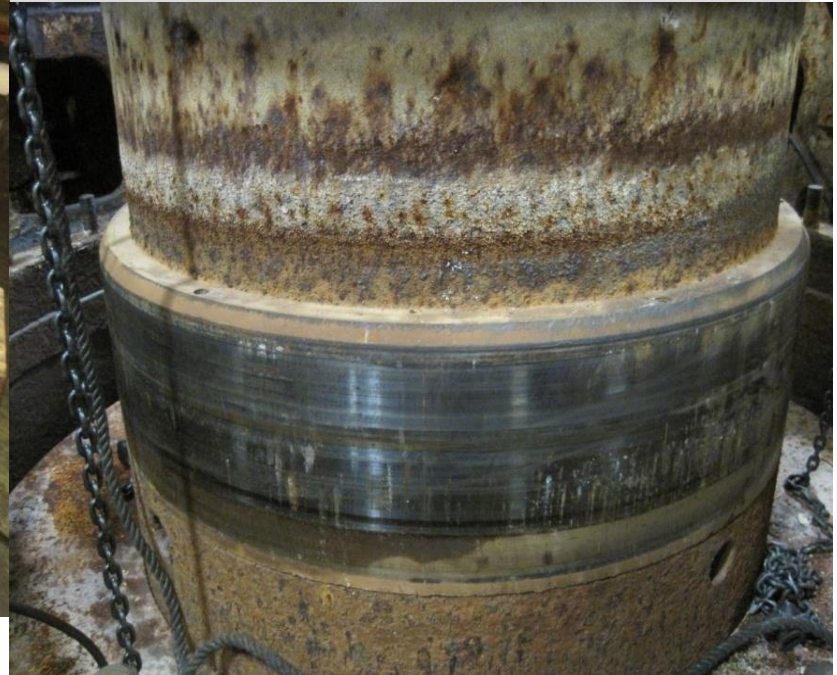
Small water opening to supply
packing stuffing box

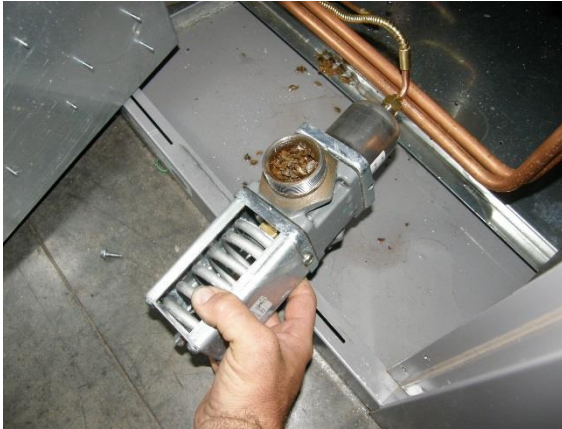
Parker Dam Biofouling – Heat Exchangers and HVAC Systems 2014

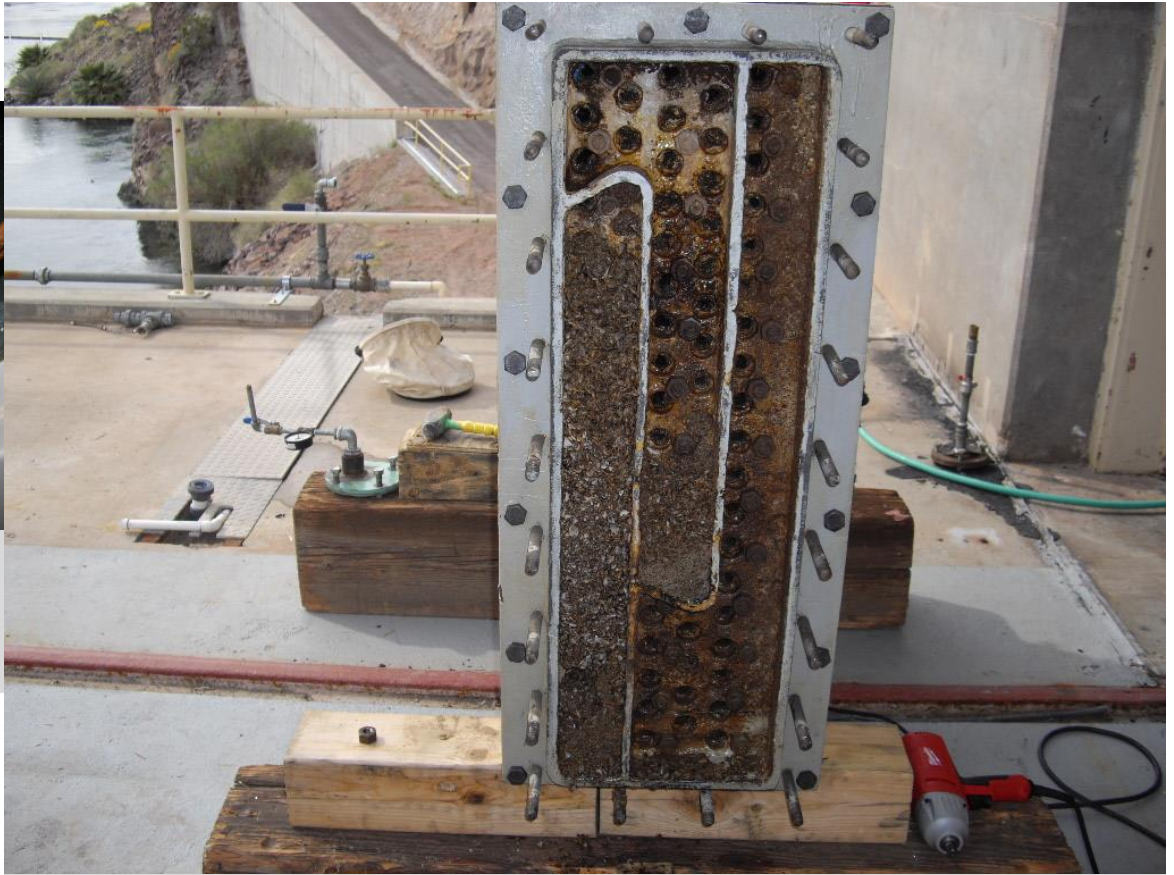
Clogged HVAC Control Valve

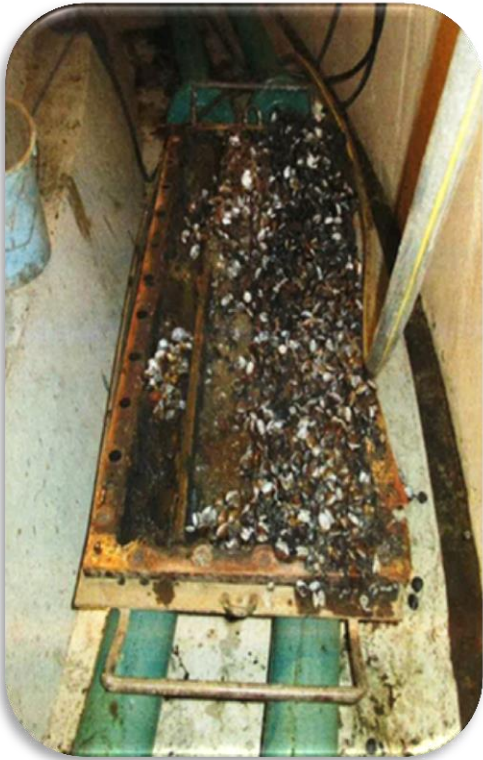
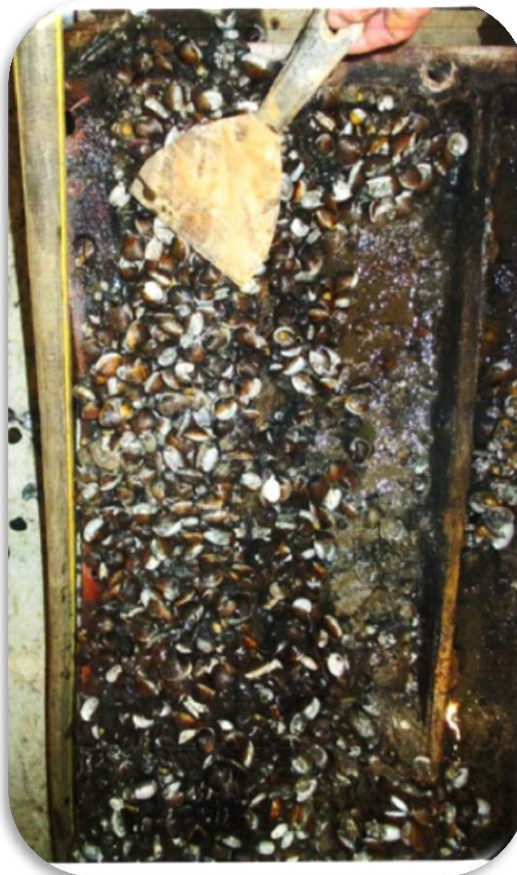
Heat Exchangers 2016 – Corp of Engineer Hydro Power Plant

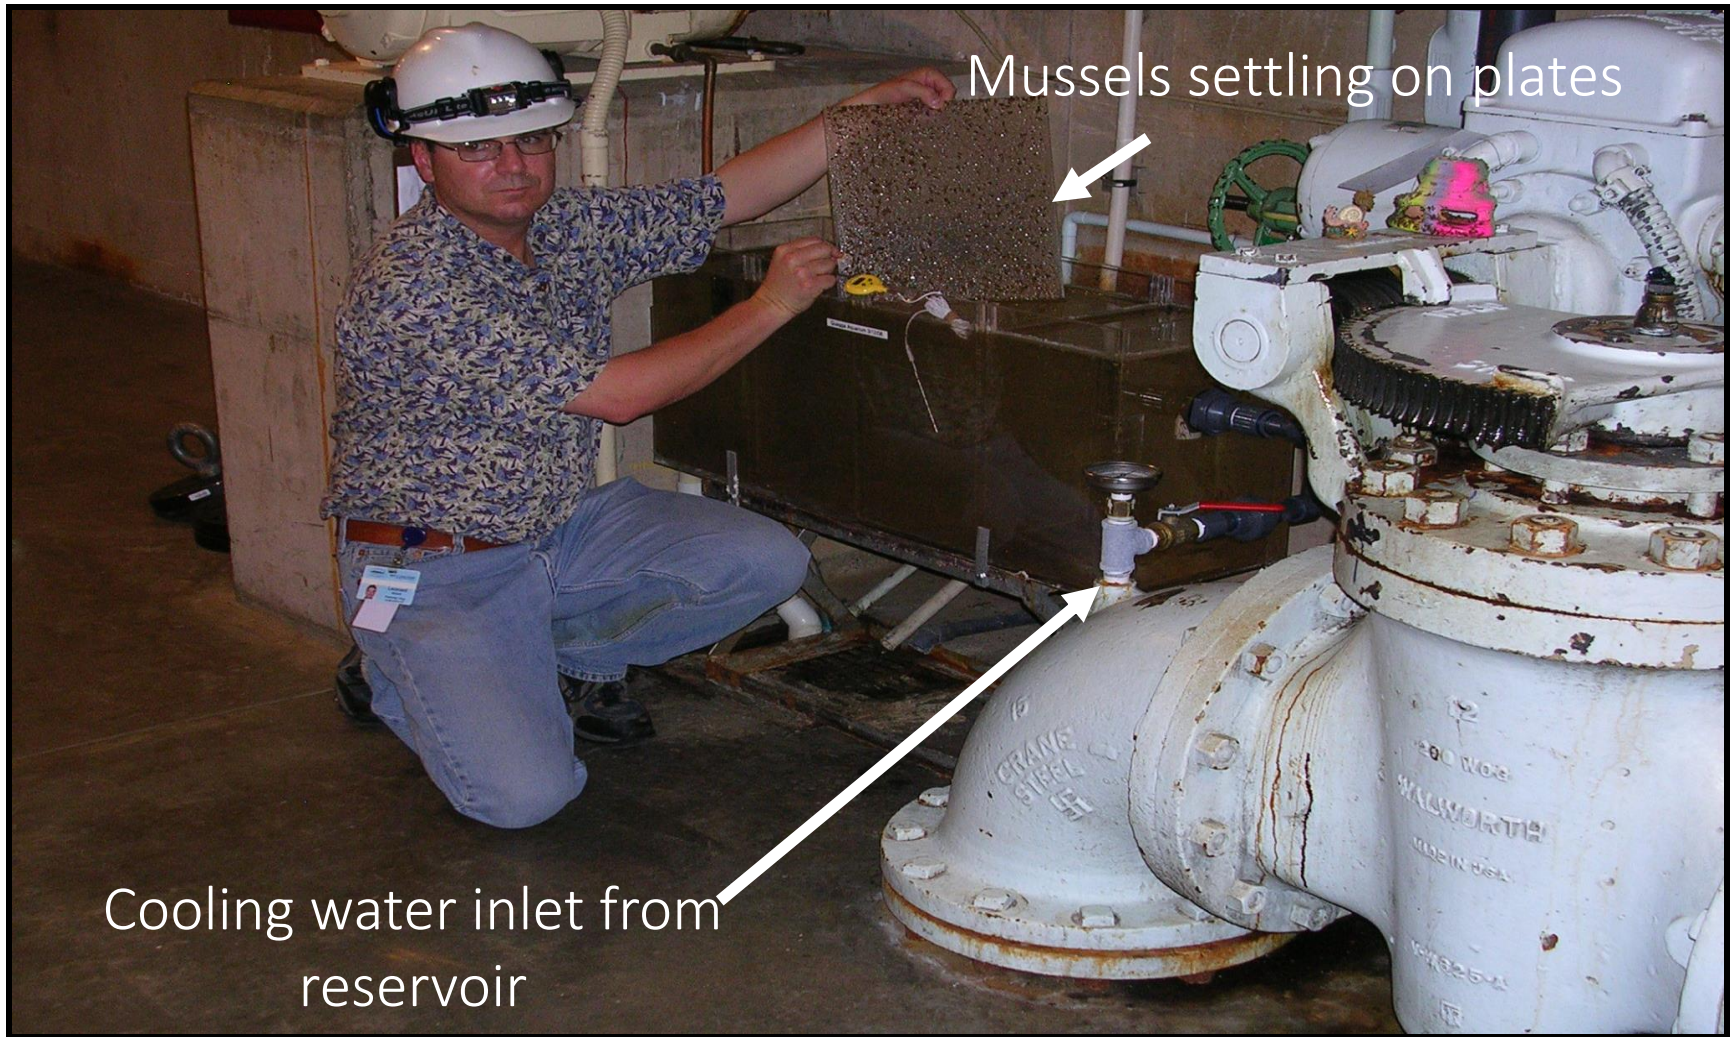
Installed Bio-Box Sampler for Monitoring

- Installed bio-boxes
- Tested micro-filtration systems - (40-80 micron)
- Fish Screens Resistance to Mussels
- Evaluating water jetting system for exterior cleaning
- Evaluating anti-foul coatings and materials to resist mussels (Dr. Allen Skaja, TSC Denver)
- Evaluation of Zequanox treatment (completed)
- Copper Ion Generator
- Copper Evaluation as Molluskcide (completed)
- Evaluating ultra-violet light treatment (on-going)

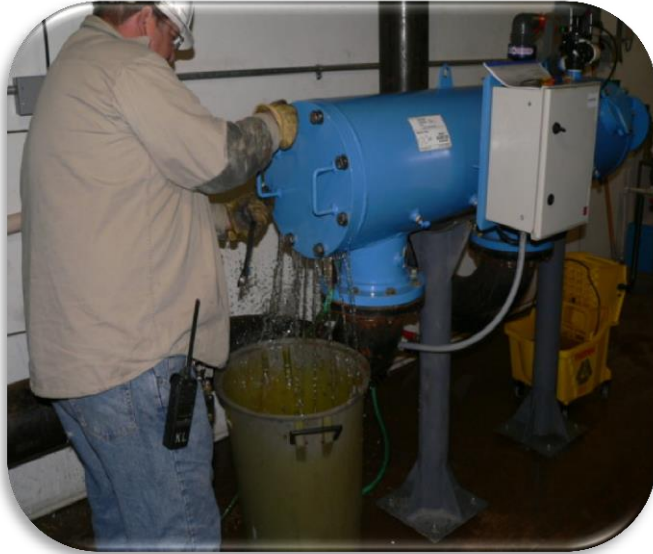
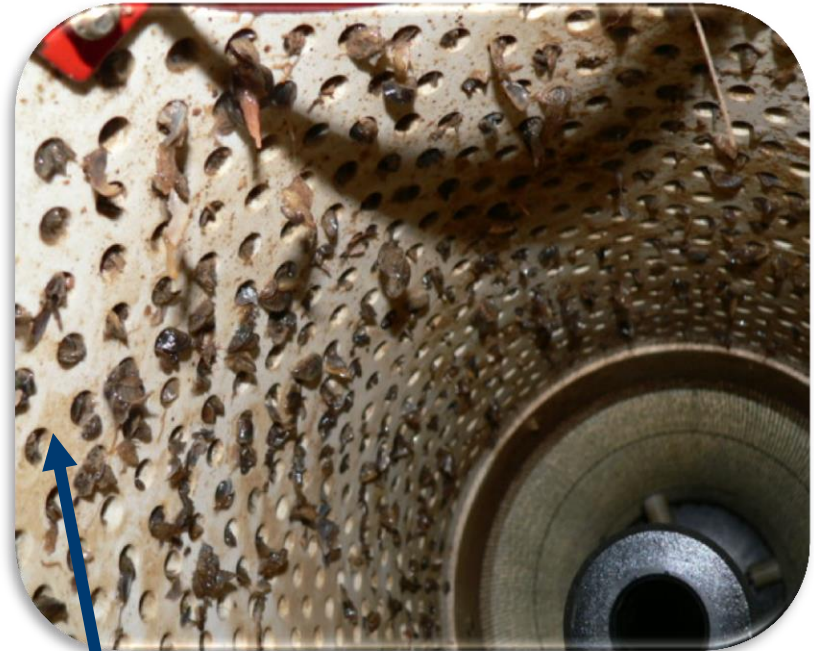
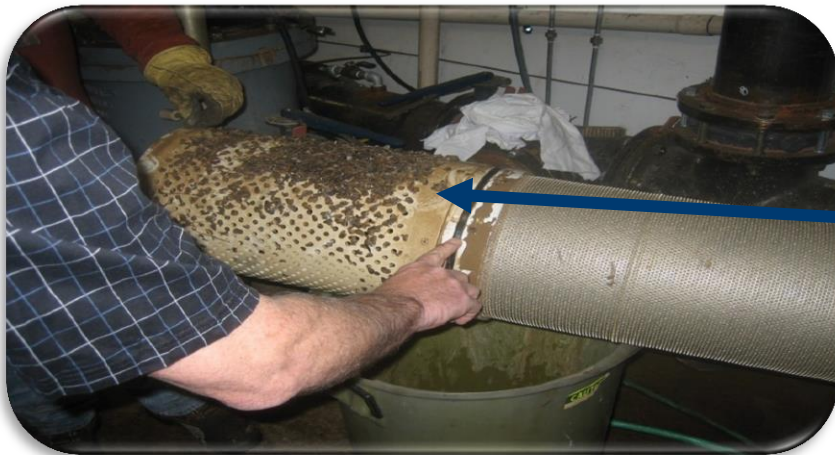
Self Cleaning Ballast Safe Filter

Pre-strainer (filter)

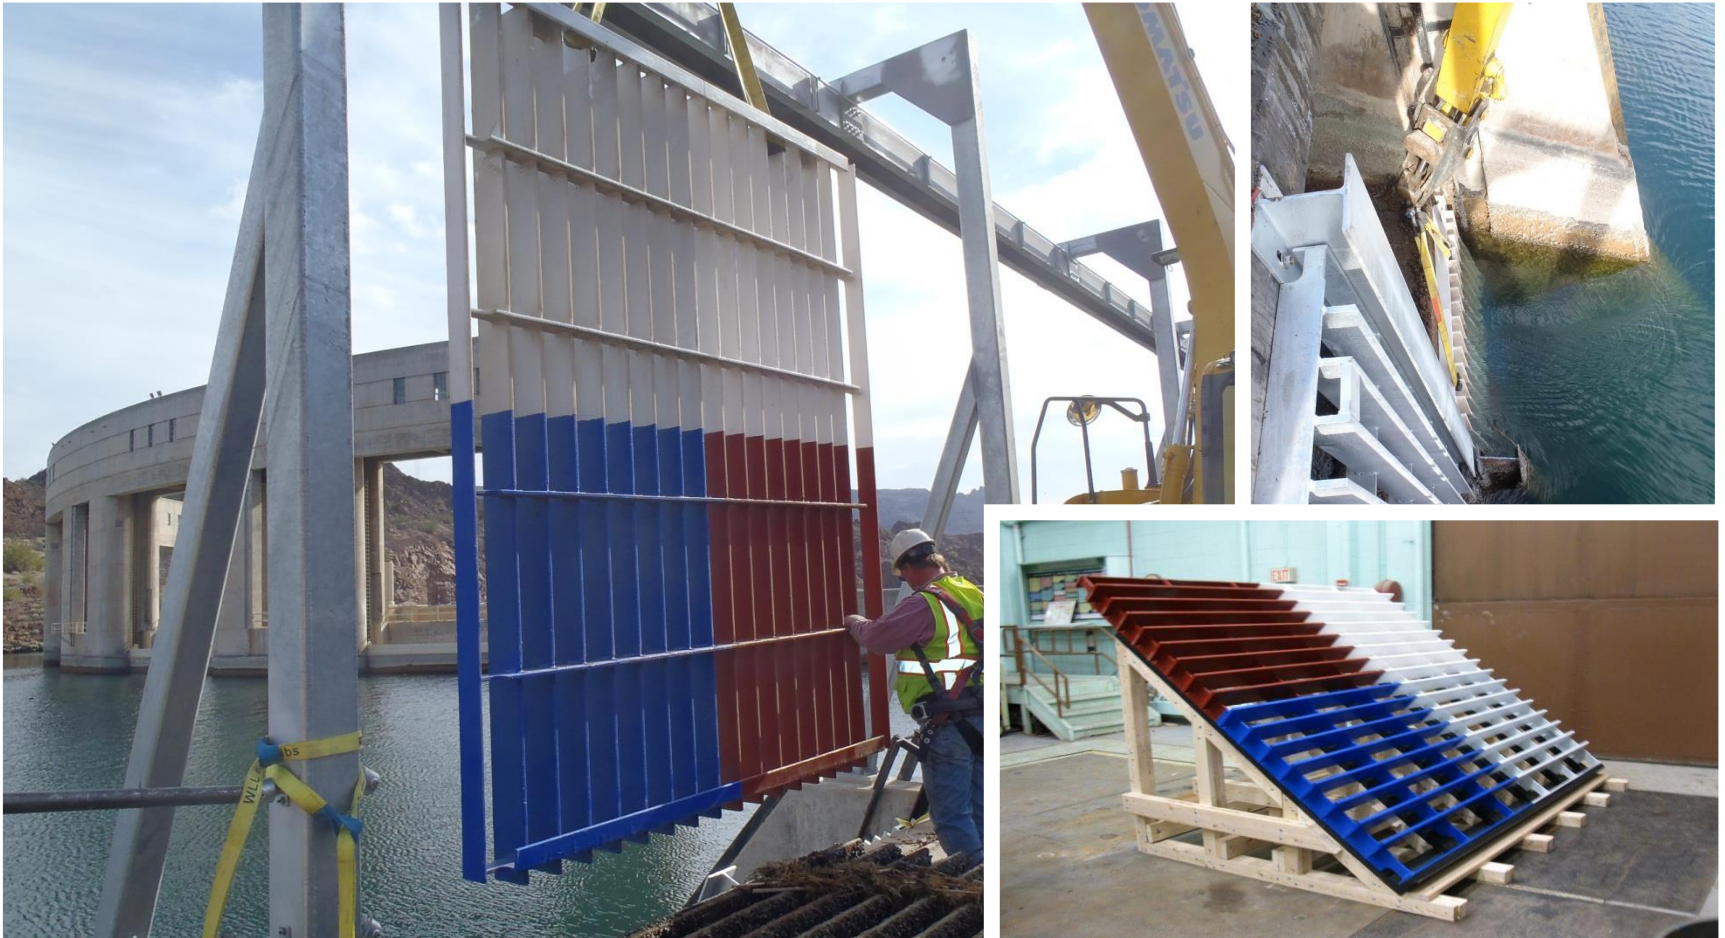
Parker Dam Trash Rake Coating Research Summer 2013

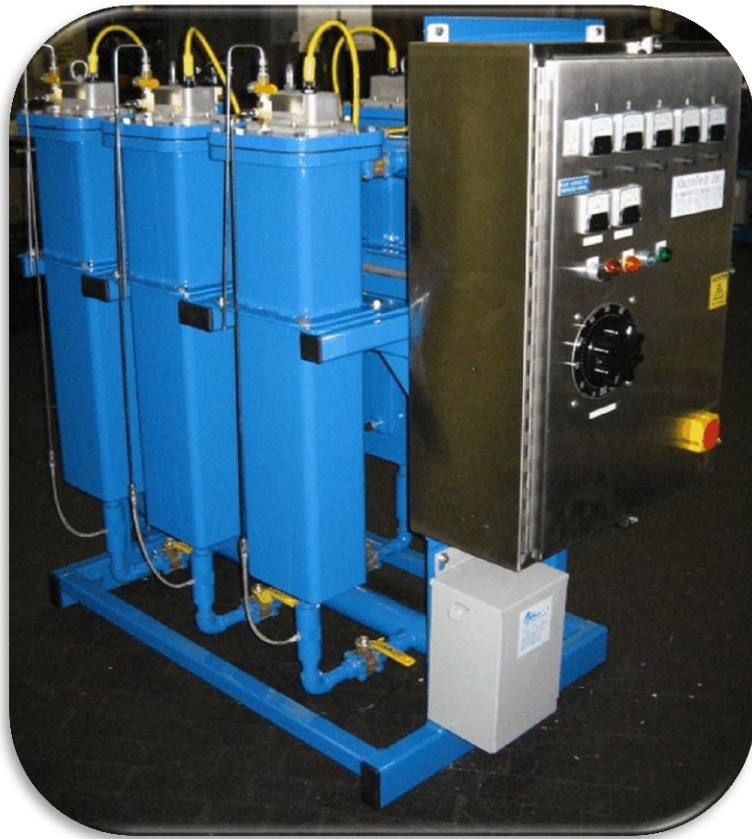
Copper Ion Generator Unit

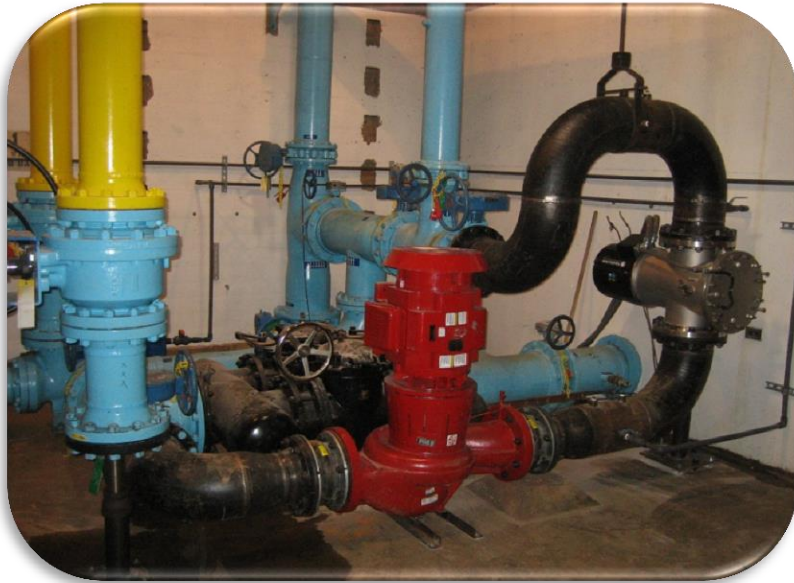
Conventional UV System (Research) Hoover Dam Cooling Water Mussel Control

August 2010, started
evaluation of 2 lamp
conventional UV system

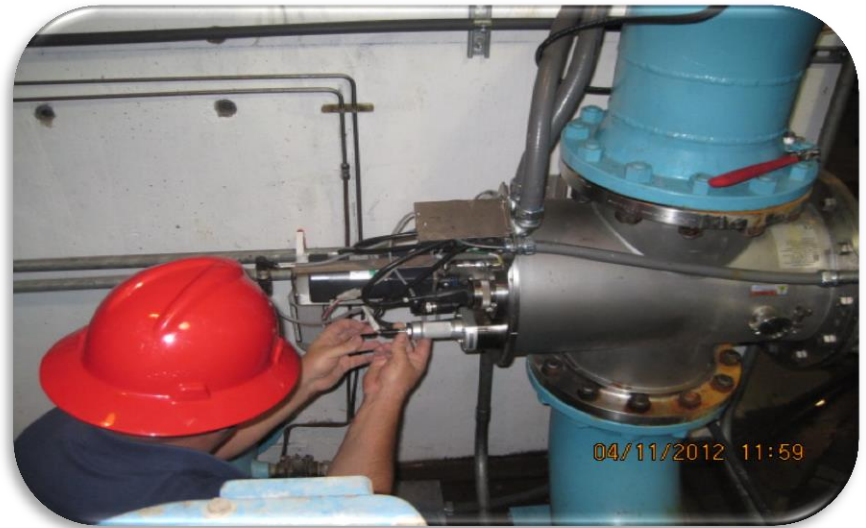
April 2011, upgraded to 4 lamp
conventional UV system to
increase dosage

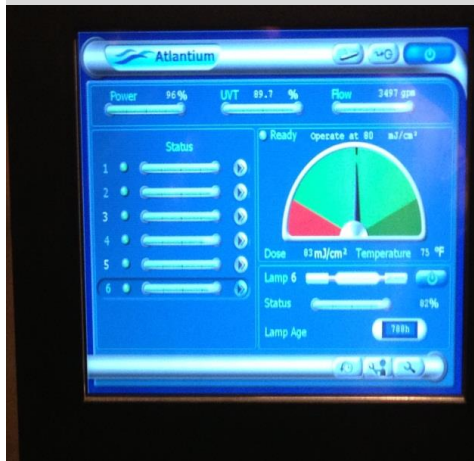
Power Plant Mussel Control System Atlantium (HOD) UV Light System

\$120K with UVT of
85 dosage of 100
mj/cm²

UV dose measured
in real-time

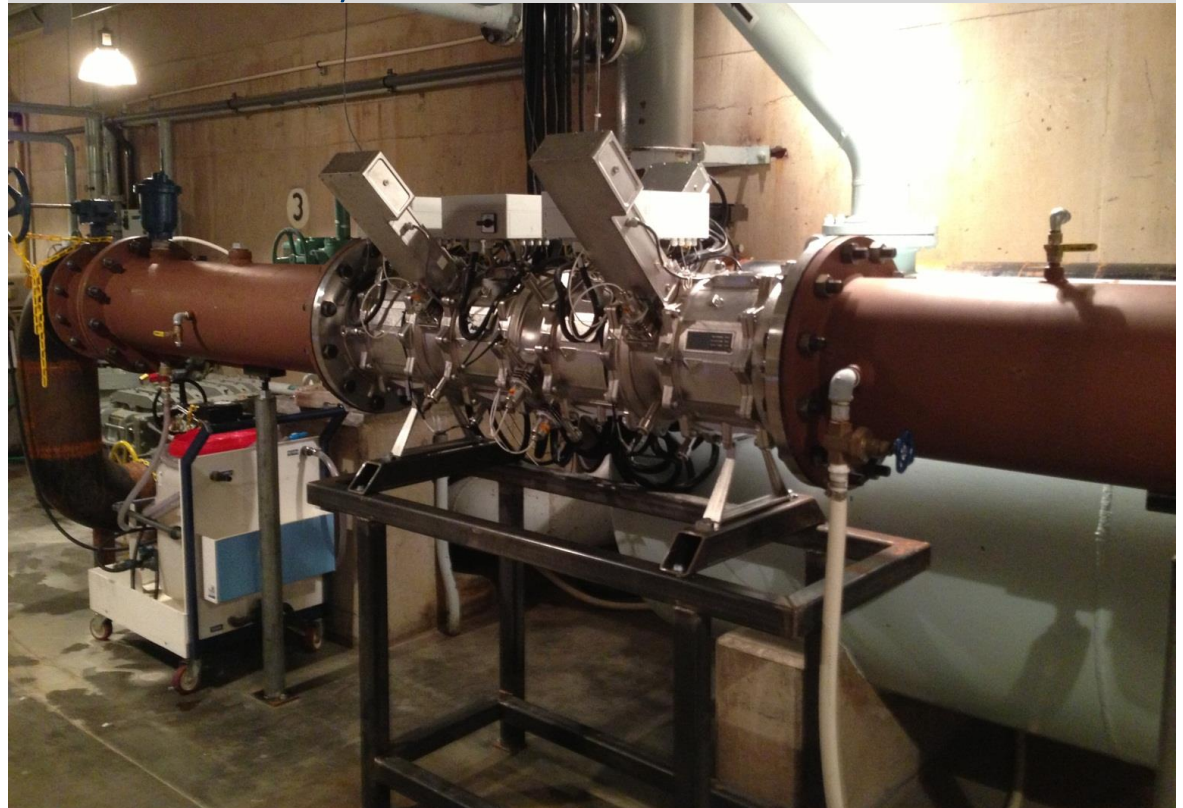
HOD UV Cooling Water System installed July 2013 on
a 4000 GPM system

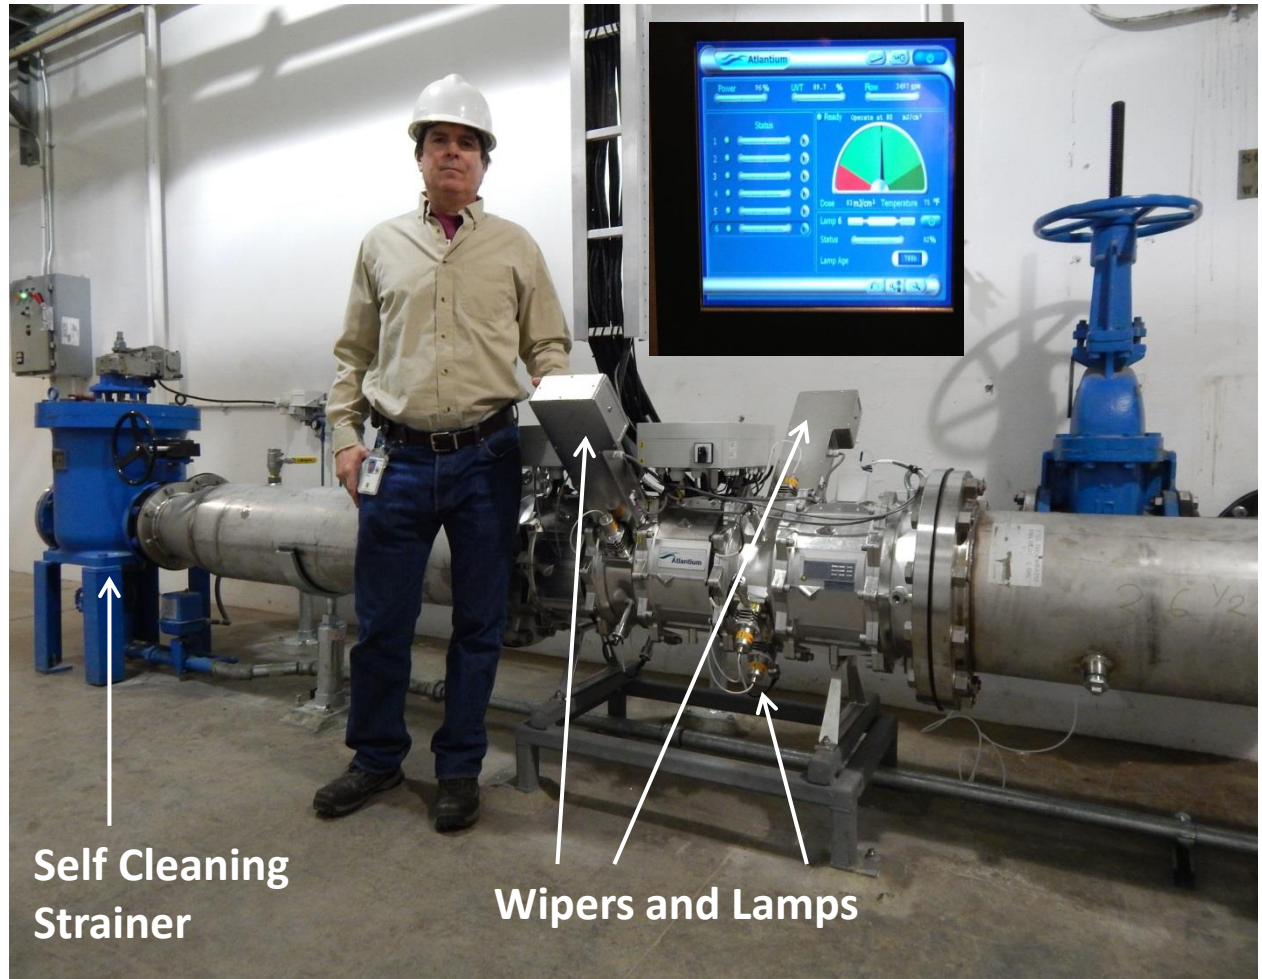
Power Plant Parker Dam Mussel Control System

HOD UV Cooling
Water System

- Installed Nov'15
- 1600 GPM system

Self Cleaning
Strainer

Wipers and Lamps

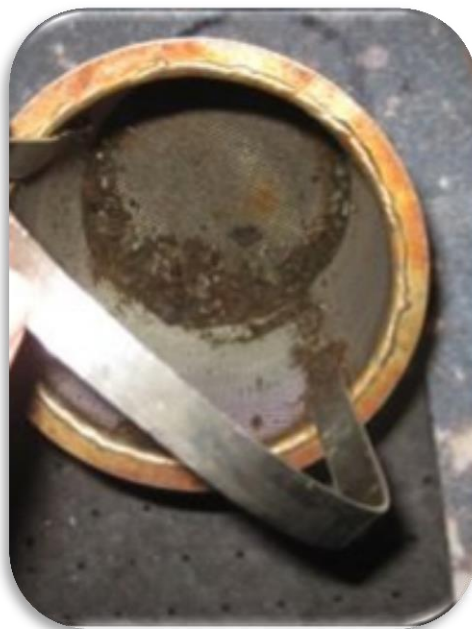
Strainer w/o HOD

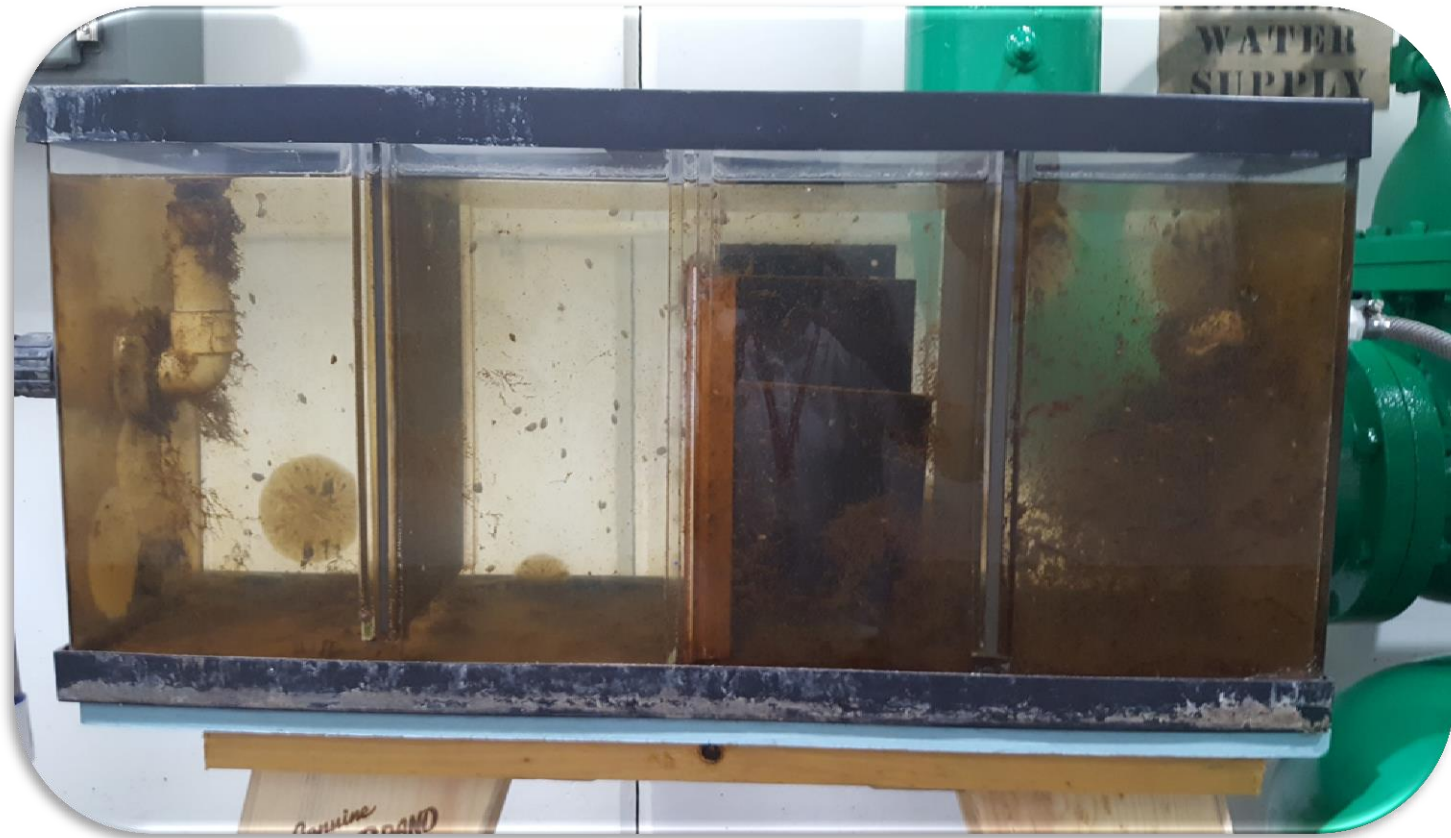
Freshwater Colonial Hydroid Prior to HOD UV at Parker Dam
