ICAIS – RESPONSE AND CONTROL

Taking No Prisoners Beating Back Invasive Species Bureau of Reclamation

Leonard Willett
Hoover Dam
Lower Colorado Region

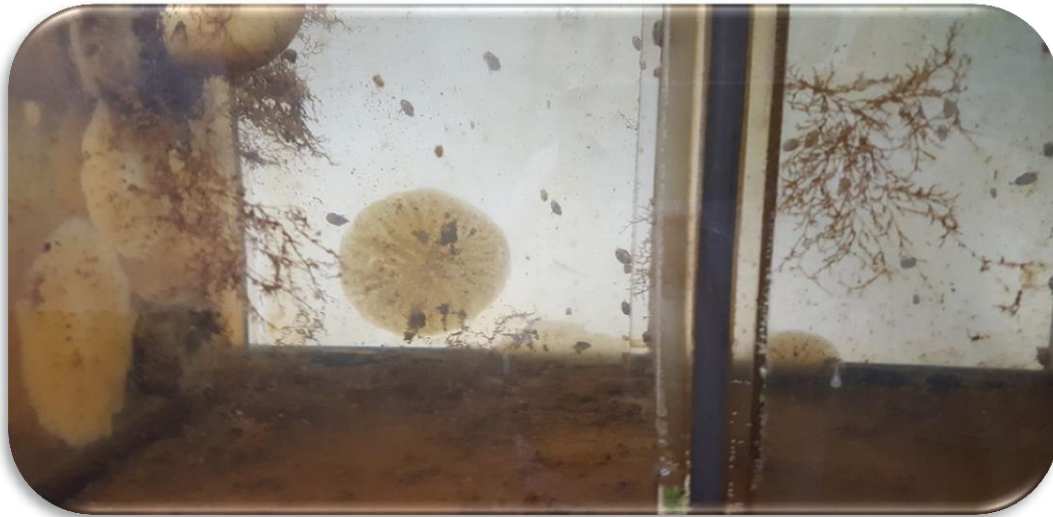
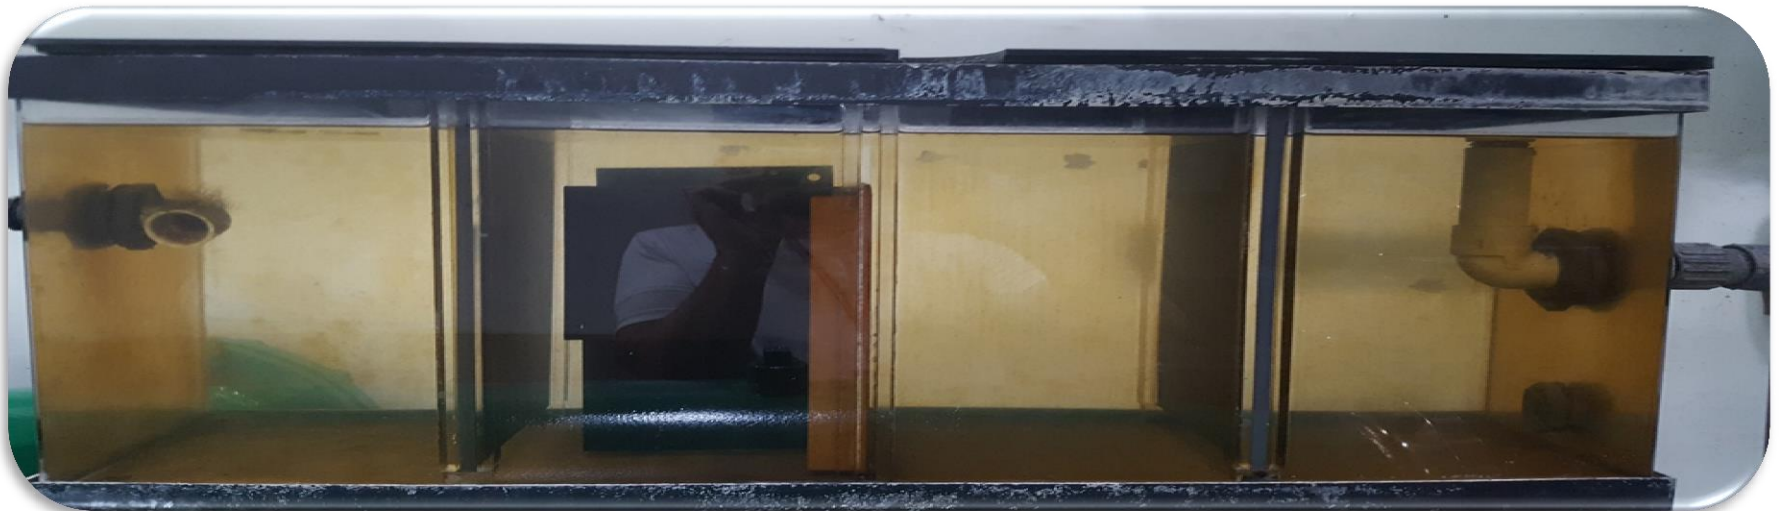
Hydroid Study Before & After HOD UV Treatment at Parker Dam

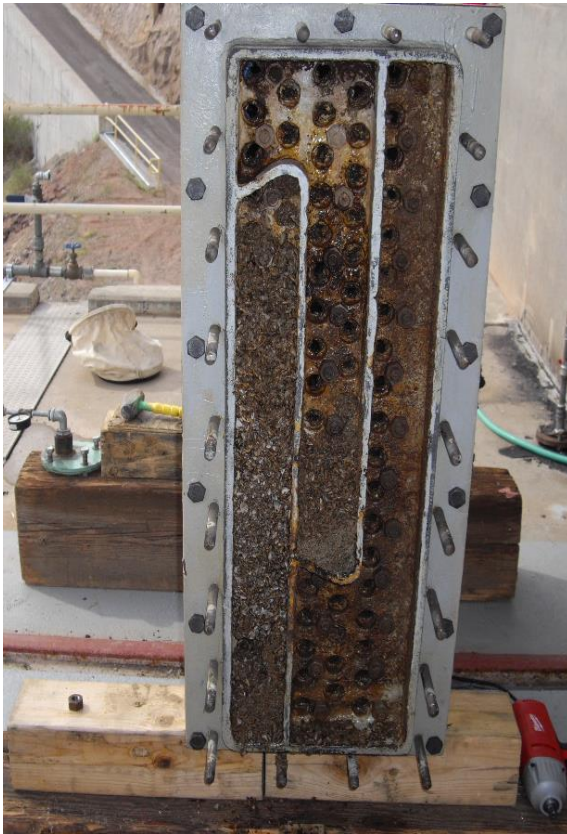
2014

Parker Dam Cooling Water Heat Exchanger

Before Atlantium HOD UV

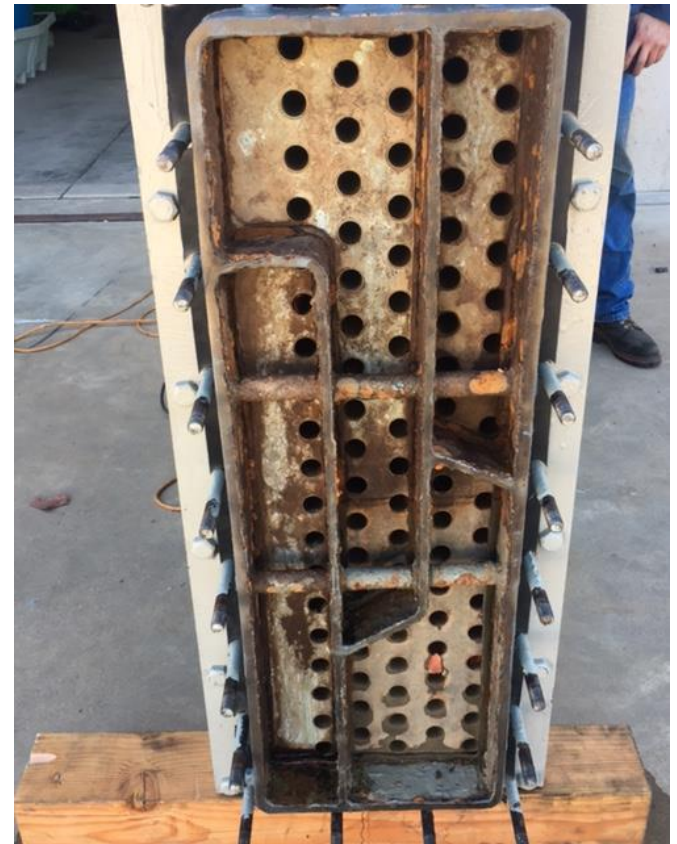
2016

After Atlantium HOD UV
