UV control of colonial hydroid biofouling

Sherri Pucherelli: Bureau of Reclamation

Renata Claudi: RNT Consulting Inc.

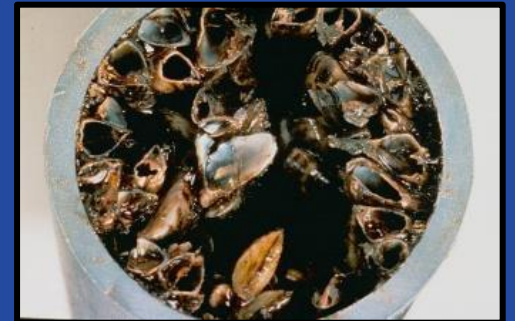
- Quagga mussel UV study at Davis Dam, AZ
- Atlantium Technologies Ltd. medium pressure UV unit
- Tested doses between 20 and 100 mJ/cm²
 - Settlement reduction between 88-99%

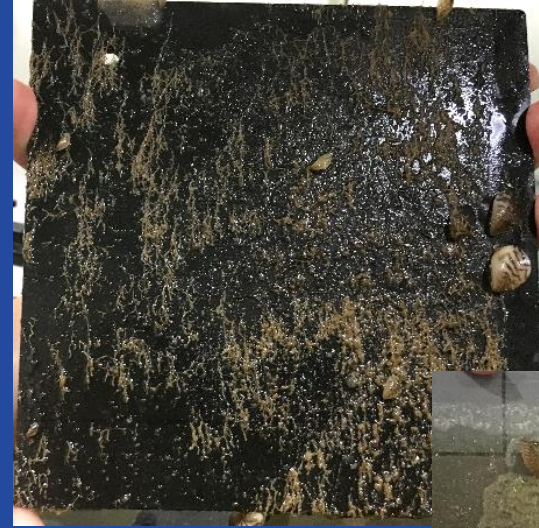
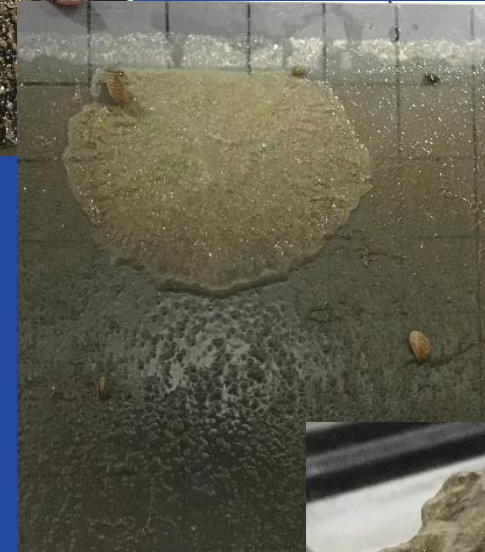
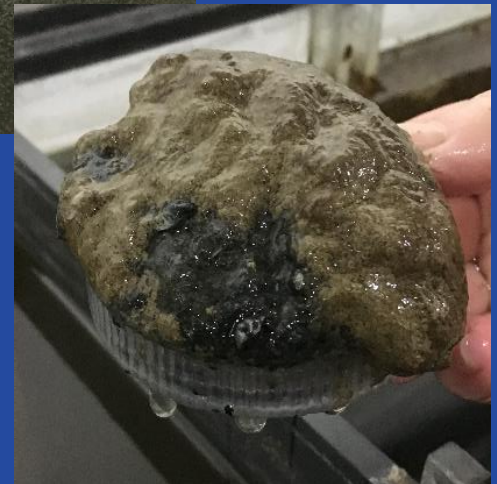
- Atlantium UV units installed at Parker Dam
- Additional biofouling issues
 - Colonial hydroid (*Cordylophora caspia*)
 - Freshwater sponge (*Ephydatia* sp.)
 - Bacterial growth

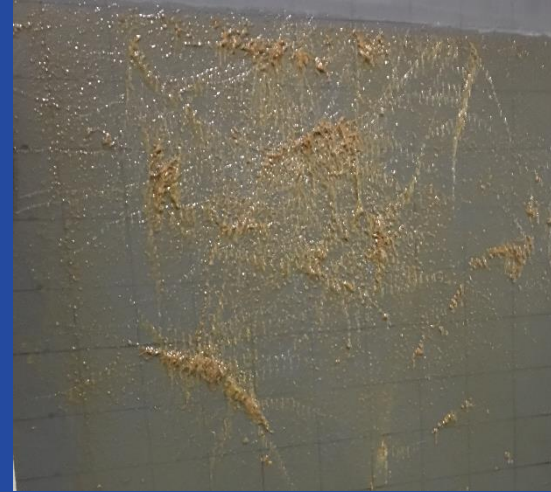
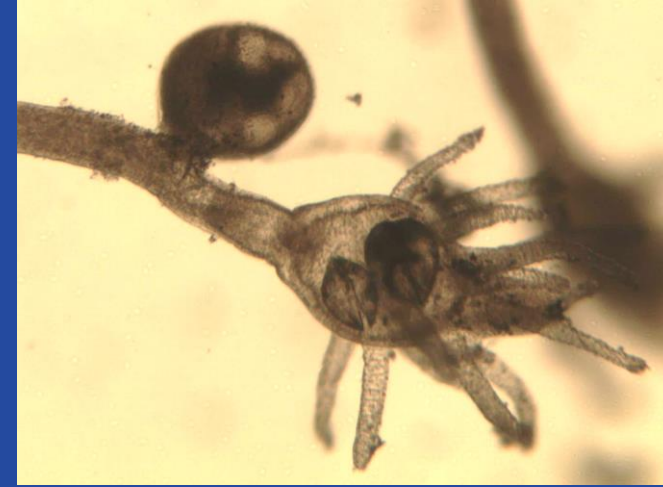
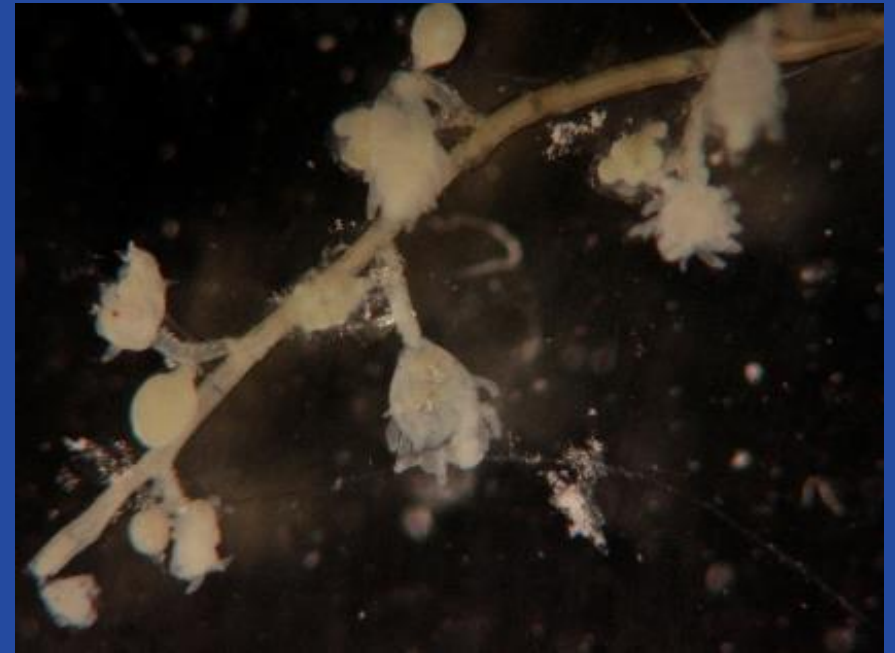
- **Colonial hydroid**
 - Invasive species
 - Significant biofouling potential at hydropower facilities
 - Carnivorous benthic predator-feeds on zooplankton
 - Colony growth and dispersal occurs by sexual reproduction (planula) and asexual budding (fragmentation)

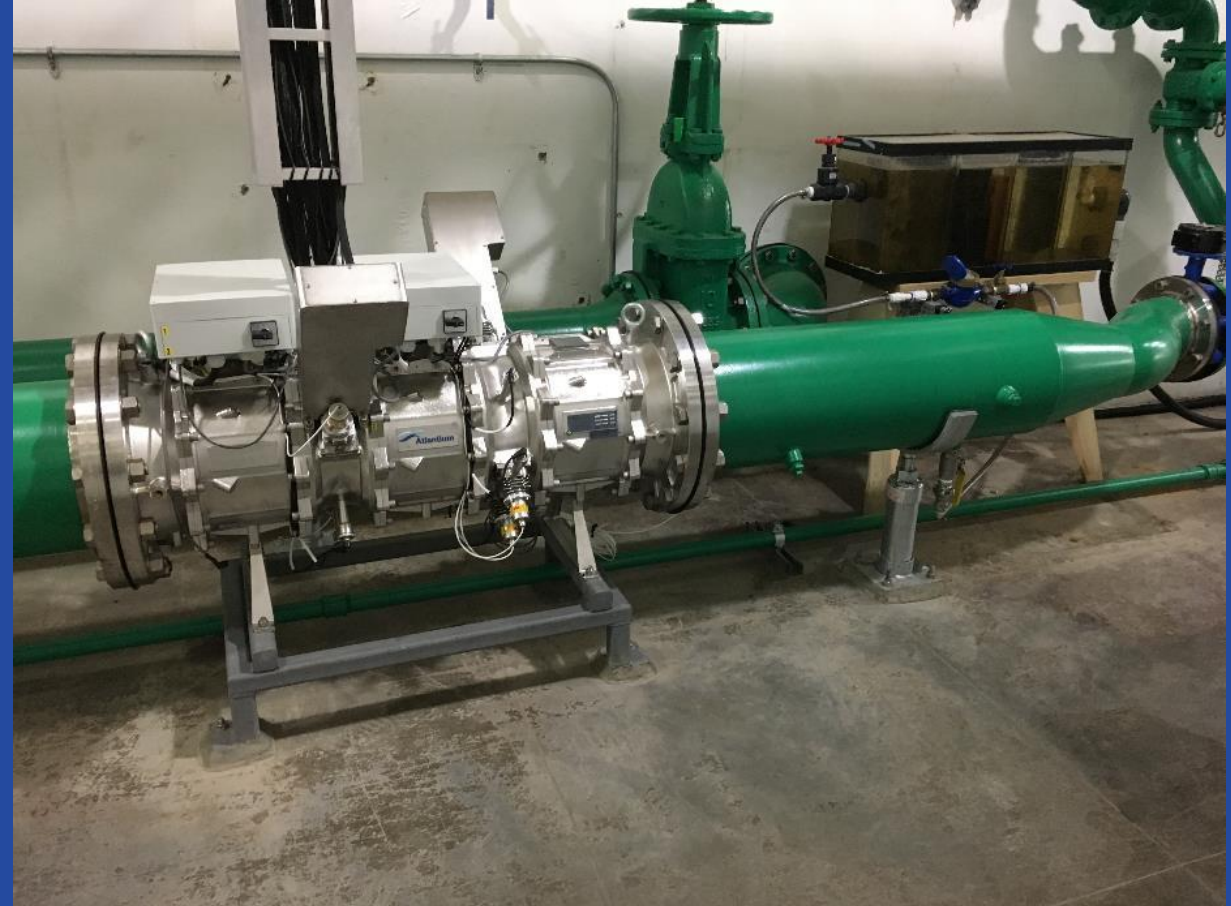
Methods

- Tests on multiple cooling lines
- Flow = 340 gpm
- Limited does control
 - No flow meter
- Bioboxes
 - Upstream and downstream
 - 2 gpm flow through
 - Settlement plates

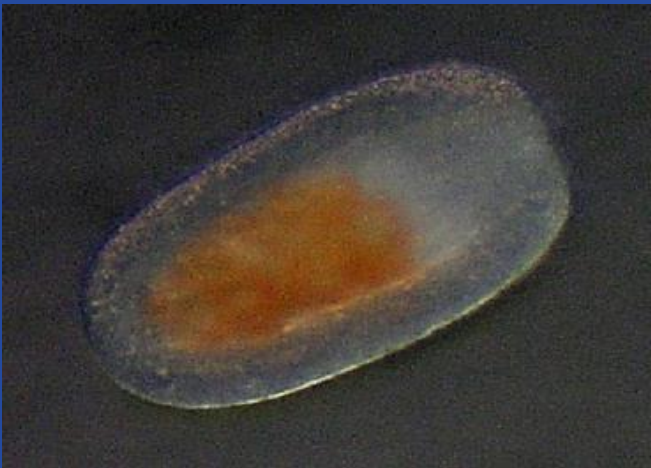
- **Monthly hydroid planula sampling**
 - 20- μ m plankton tow net
 - Microscopically analyzed and suspects genetically analyzed (PCR)
- **No planula observed during 2 year study**
 - Planula settle quickly after release
- **Colonization of bioboxes likely a result of fragmentation**

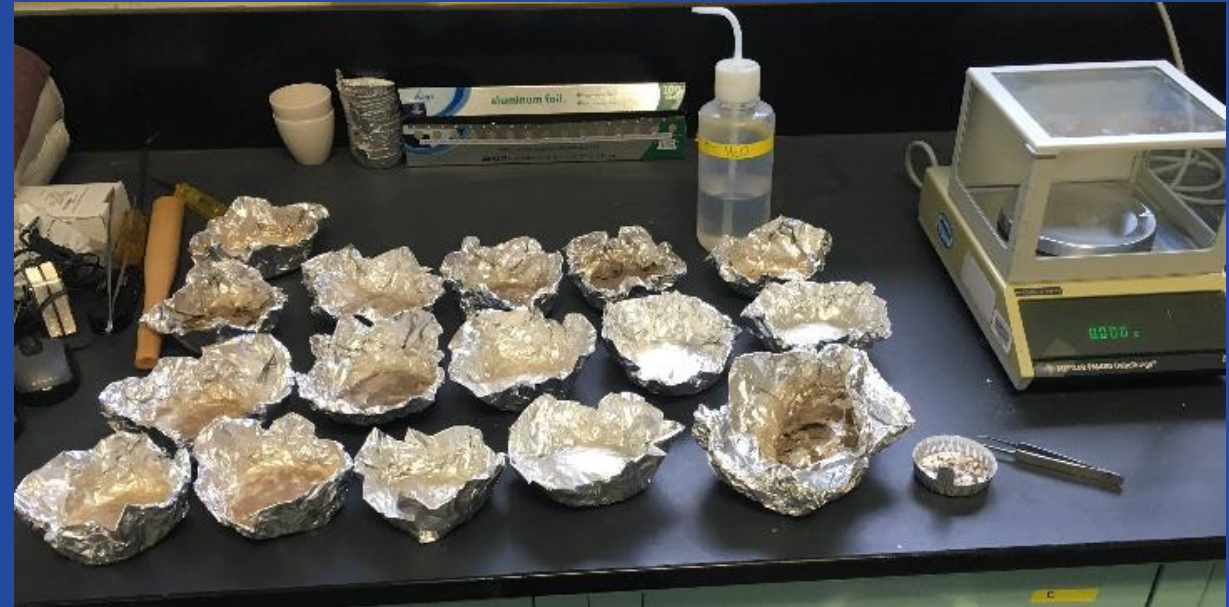
Methods

- Dry weight of biomass accumulation
 - 6 plates per biobox
 - 3 monthly
 - 3 six months
- Hydroid colony counts
 - Plate counts not representative
 - Hydroid settles on walls and bottom of the biobox

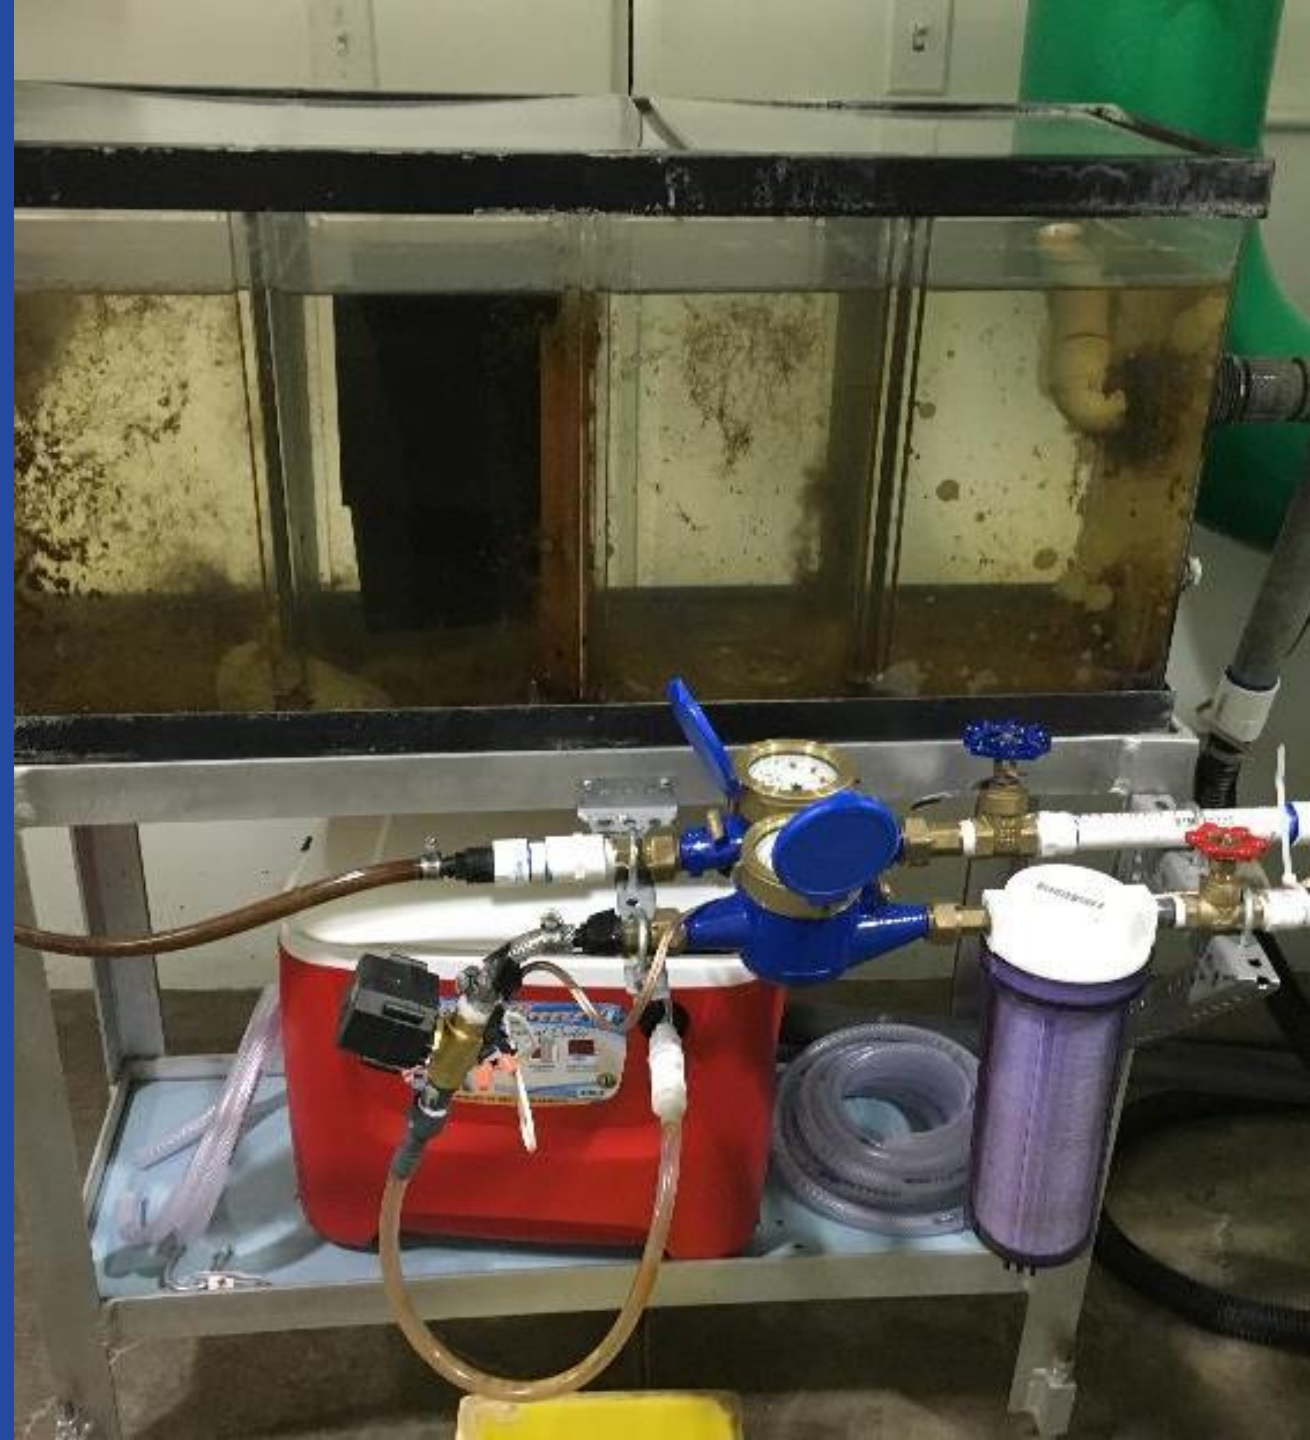
Methods

- **Microbial monitoring**
 - Installed small bioboxes with 100 μm cartridge filters
 - Adenosine triphosphate (ATP)
 - Luminultra® test kit
 - Biological activity reaction tests (BART)

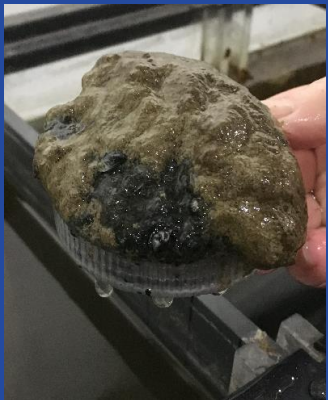
- **Control – Unit 4**

96% organic (LOI test)

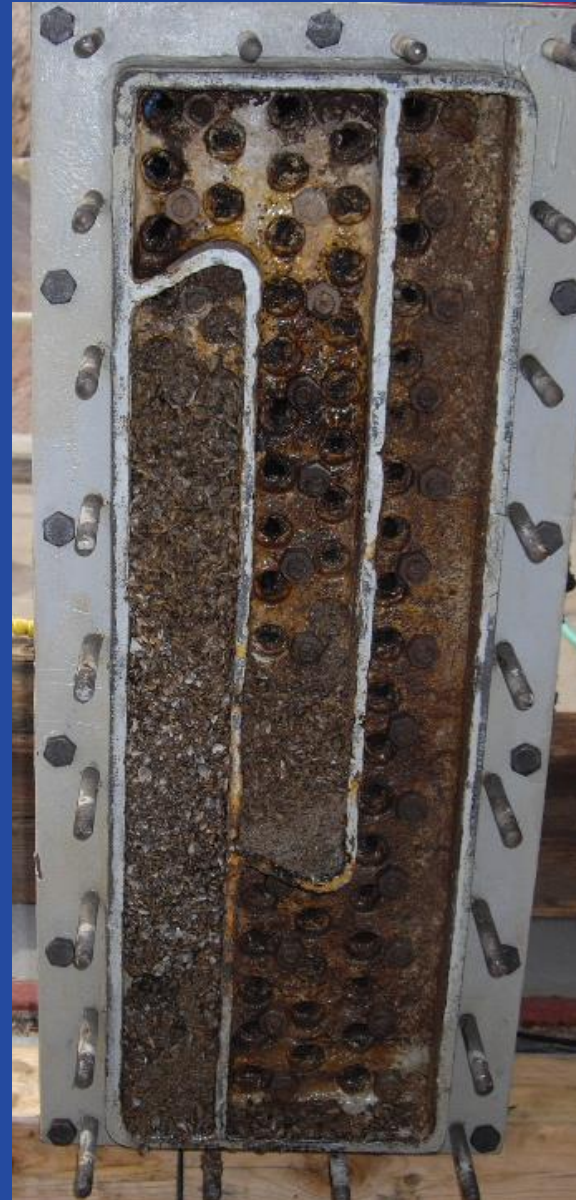
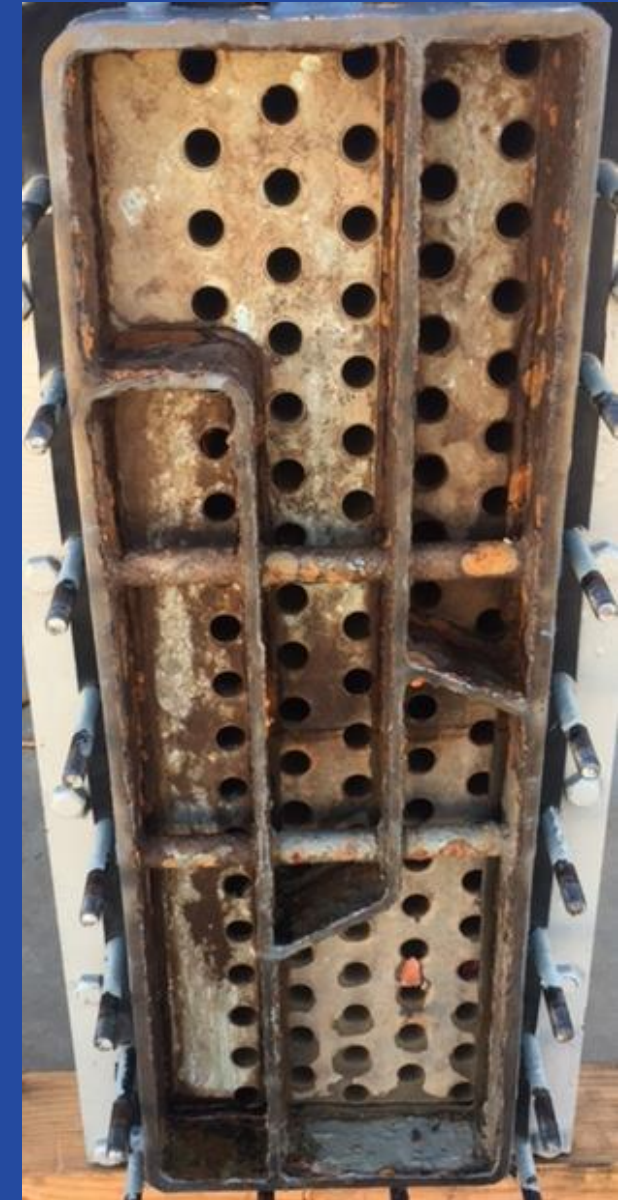
- O&M reduced at Parker Dam since UV installed
- Before UV
 - 16 coolers replaced per year
 - 640 staff hours + materials
- After UV
 - 4 coolers replaced per year
 - No units re-packed
 - Less scale on heat-exchangers
 - 160 staff hours + materials
